**Appendix A:
REFERENCES and USEFUL WEBSITES**

I.2.2 Seismic Hazards Mapping Act

Active and Potentially Active Faults

Within about 50 miles of Coachella, California

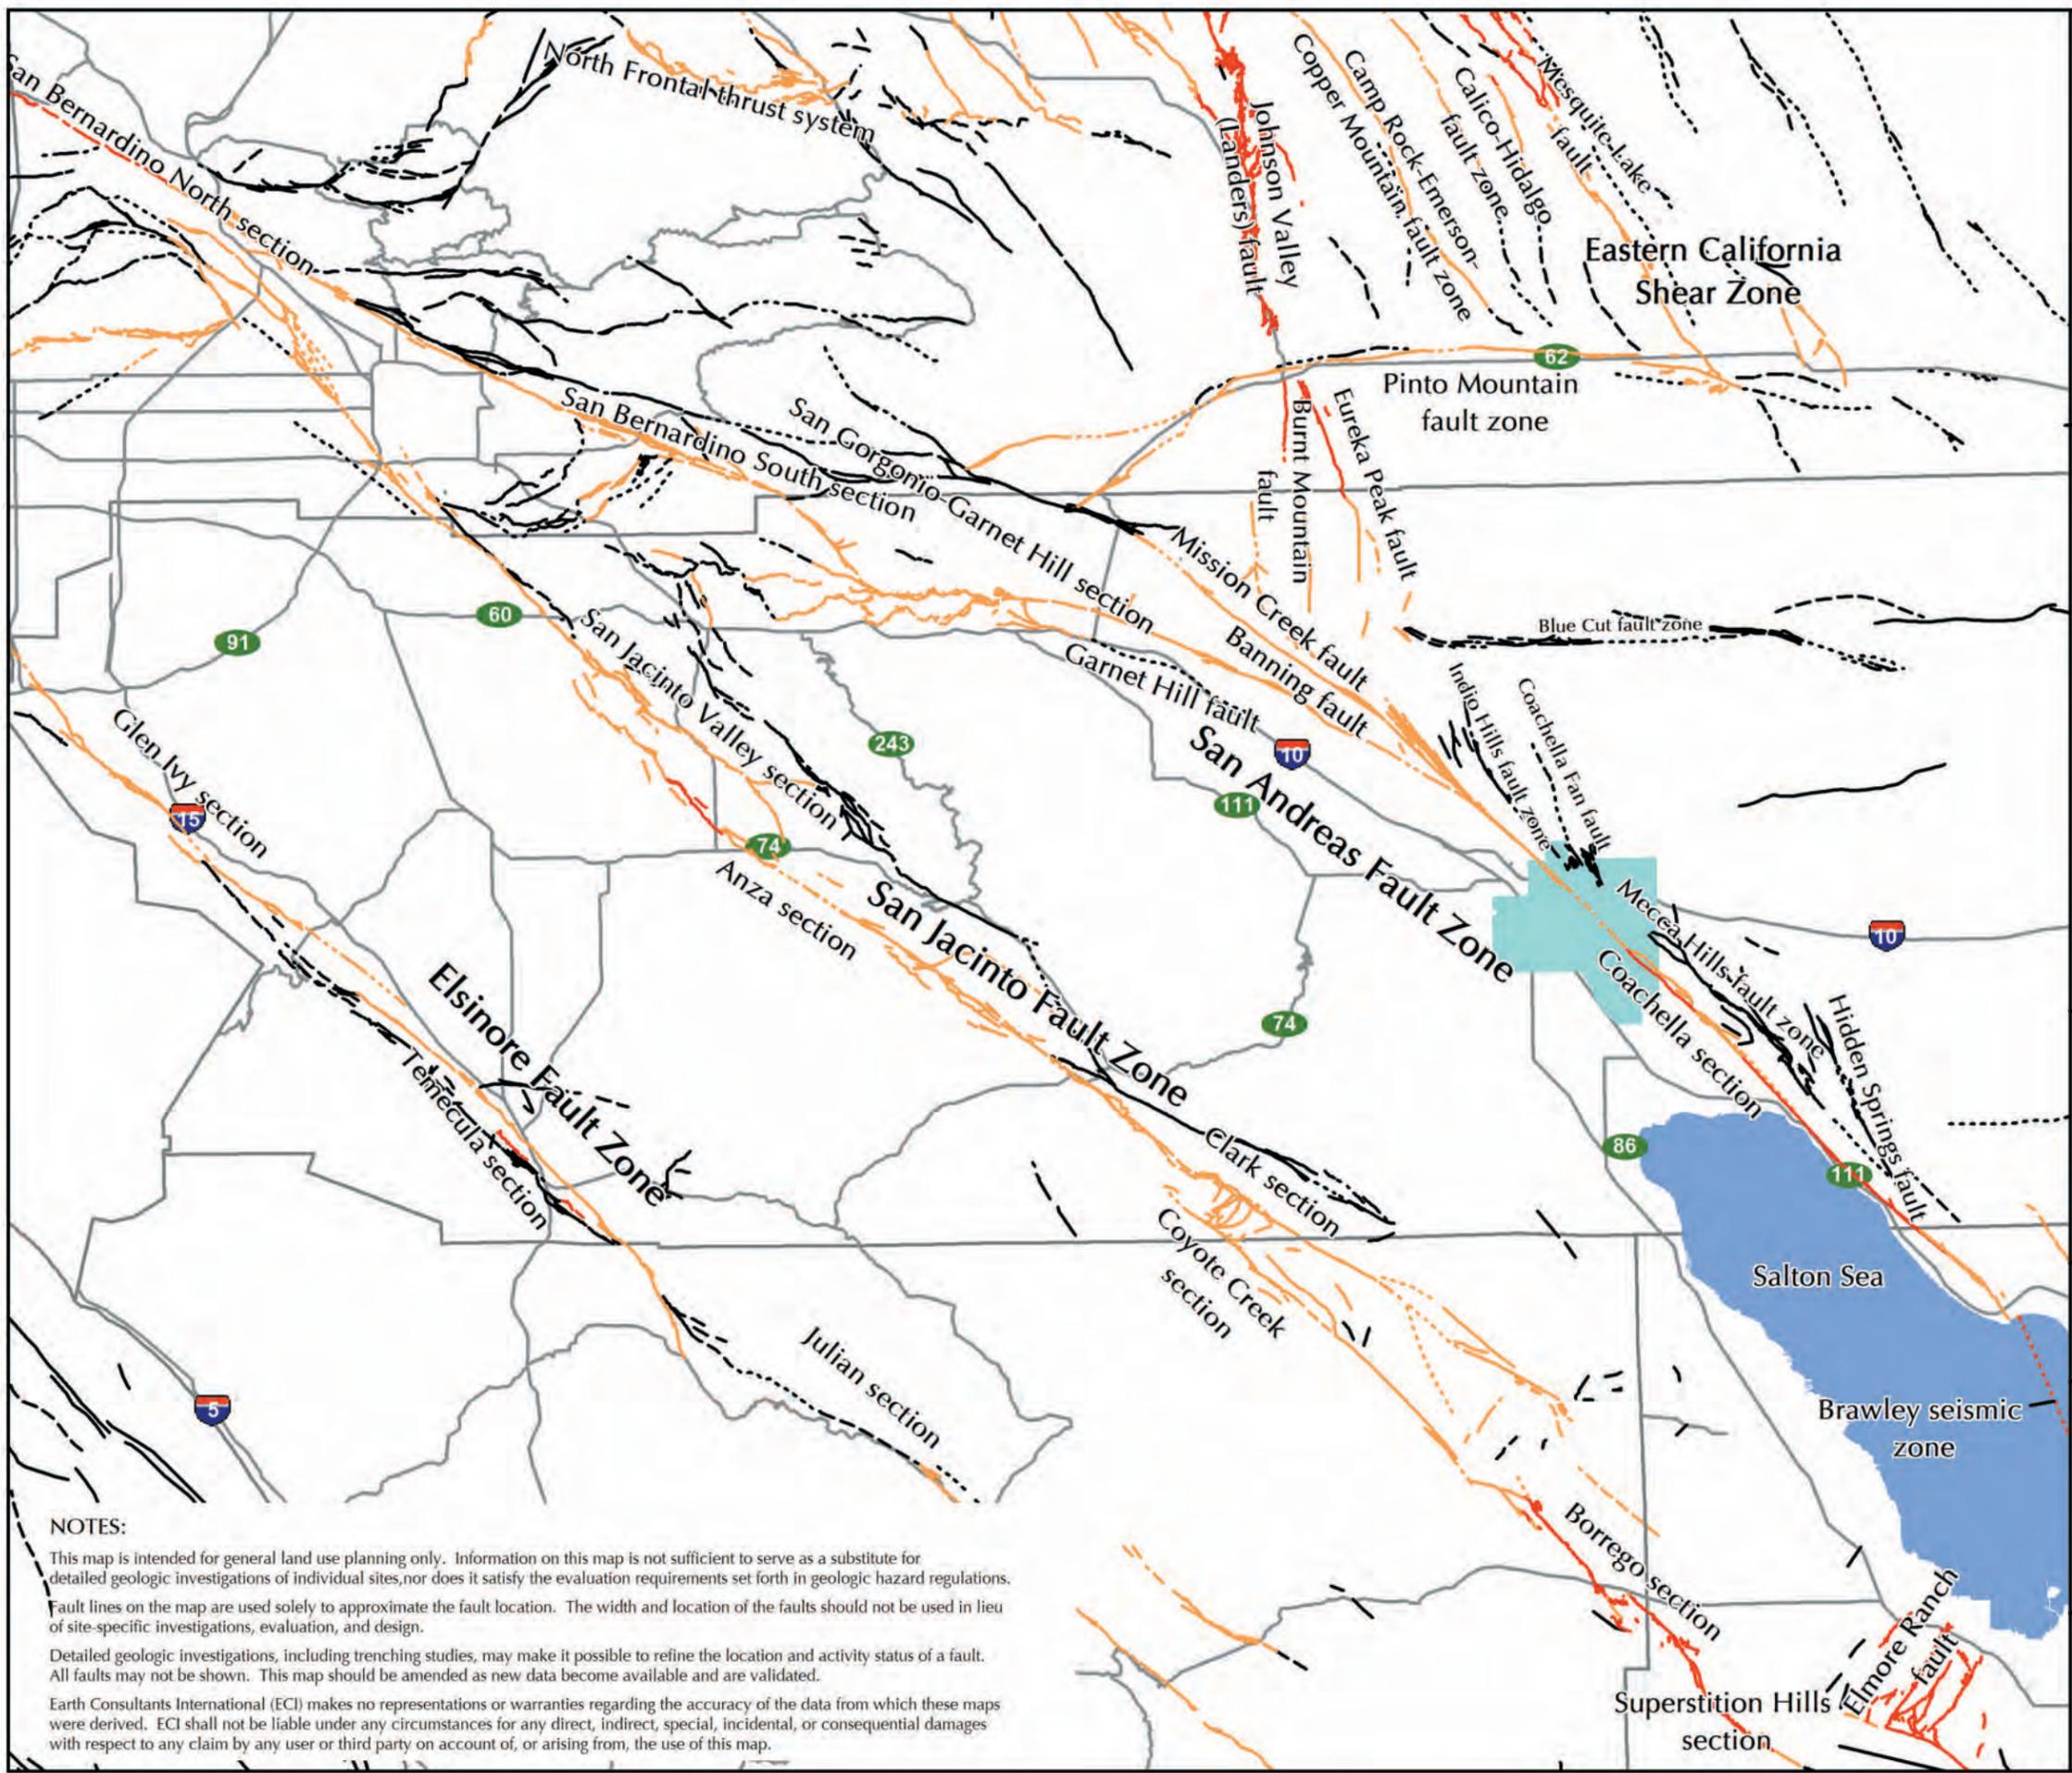
- Fault; solid where location known, dashed where approximate, dotted where concealed. Color indicates age of movement on fault.
- Age of last fault displacement.
- Fault Showing Evidence of Historic Rupture (Active).
- Fault Showing Evidence of Holocene Rupture (Active).
- Fault Showing Evidence of Quaternary and Late Quaternary Rupture (Potentially Active).
- Coachella General Plan Area

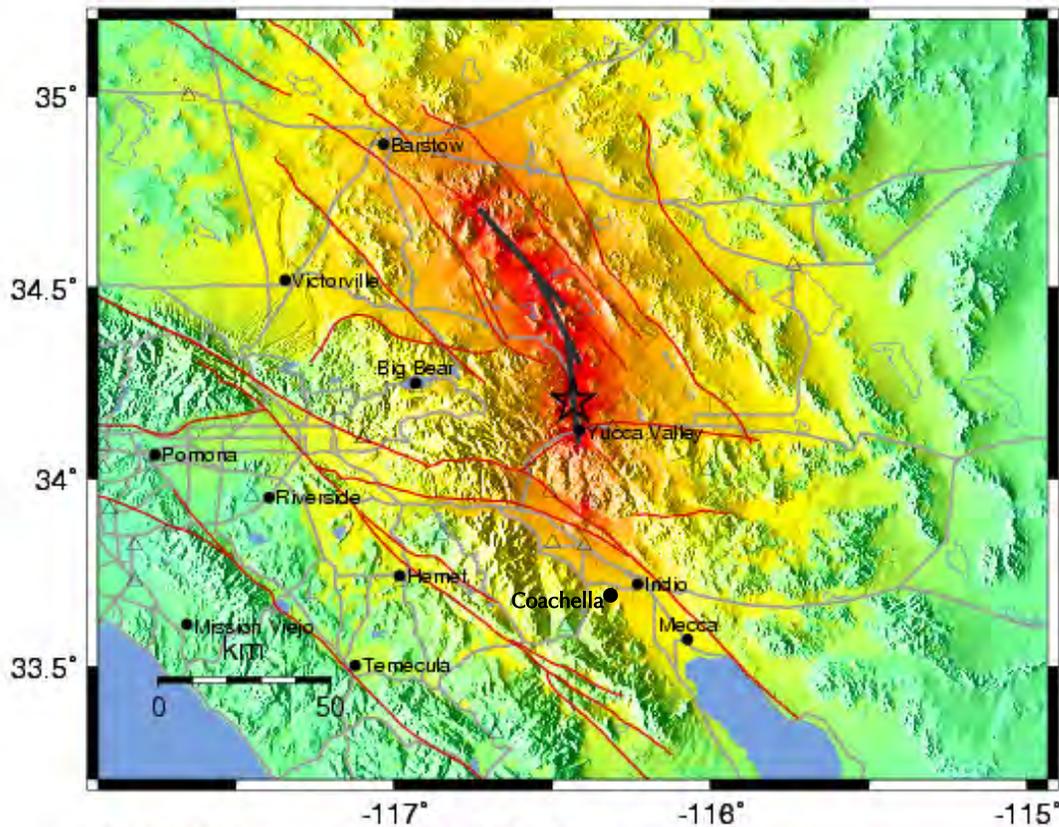
Figure I-3: Modified Mercalli Intensity ShakeMap for the June 28, 1992 Landers Earthquake

PERCEIVED SHAKING	Not felt	Weak	Light	Moderate	Strong	Very strong	Severe	Violent	Extreme
POTENTIAL DAMAGE	none	none	none	Very light	Light	Moderate	Moderate/Heavy	Heavy	Very Heavy
PEAK AOC.(%g)	<.17	.17-1.4	1.4-3.9	3.9-9.2	9.2-18	18-34	34-65	65-124	>124
PEAK VEL.(cm/s)	<0.1	0.1-1.1	1.1-3.4	3.4-8.1	8.1-18	18-31	31-60	60-118	>118
INSTRUMENTAL INTENSITY	I	II-III	IV	V	VI	VII	VIII	IX	X+

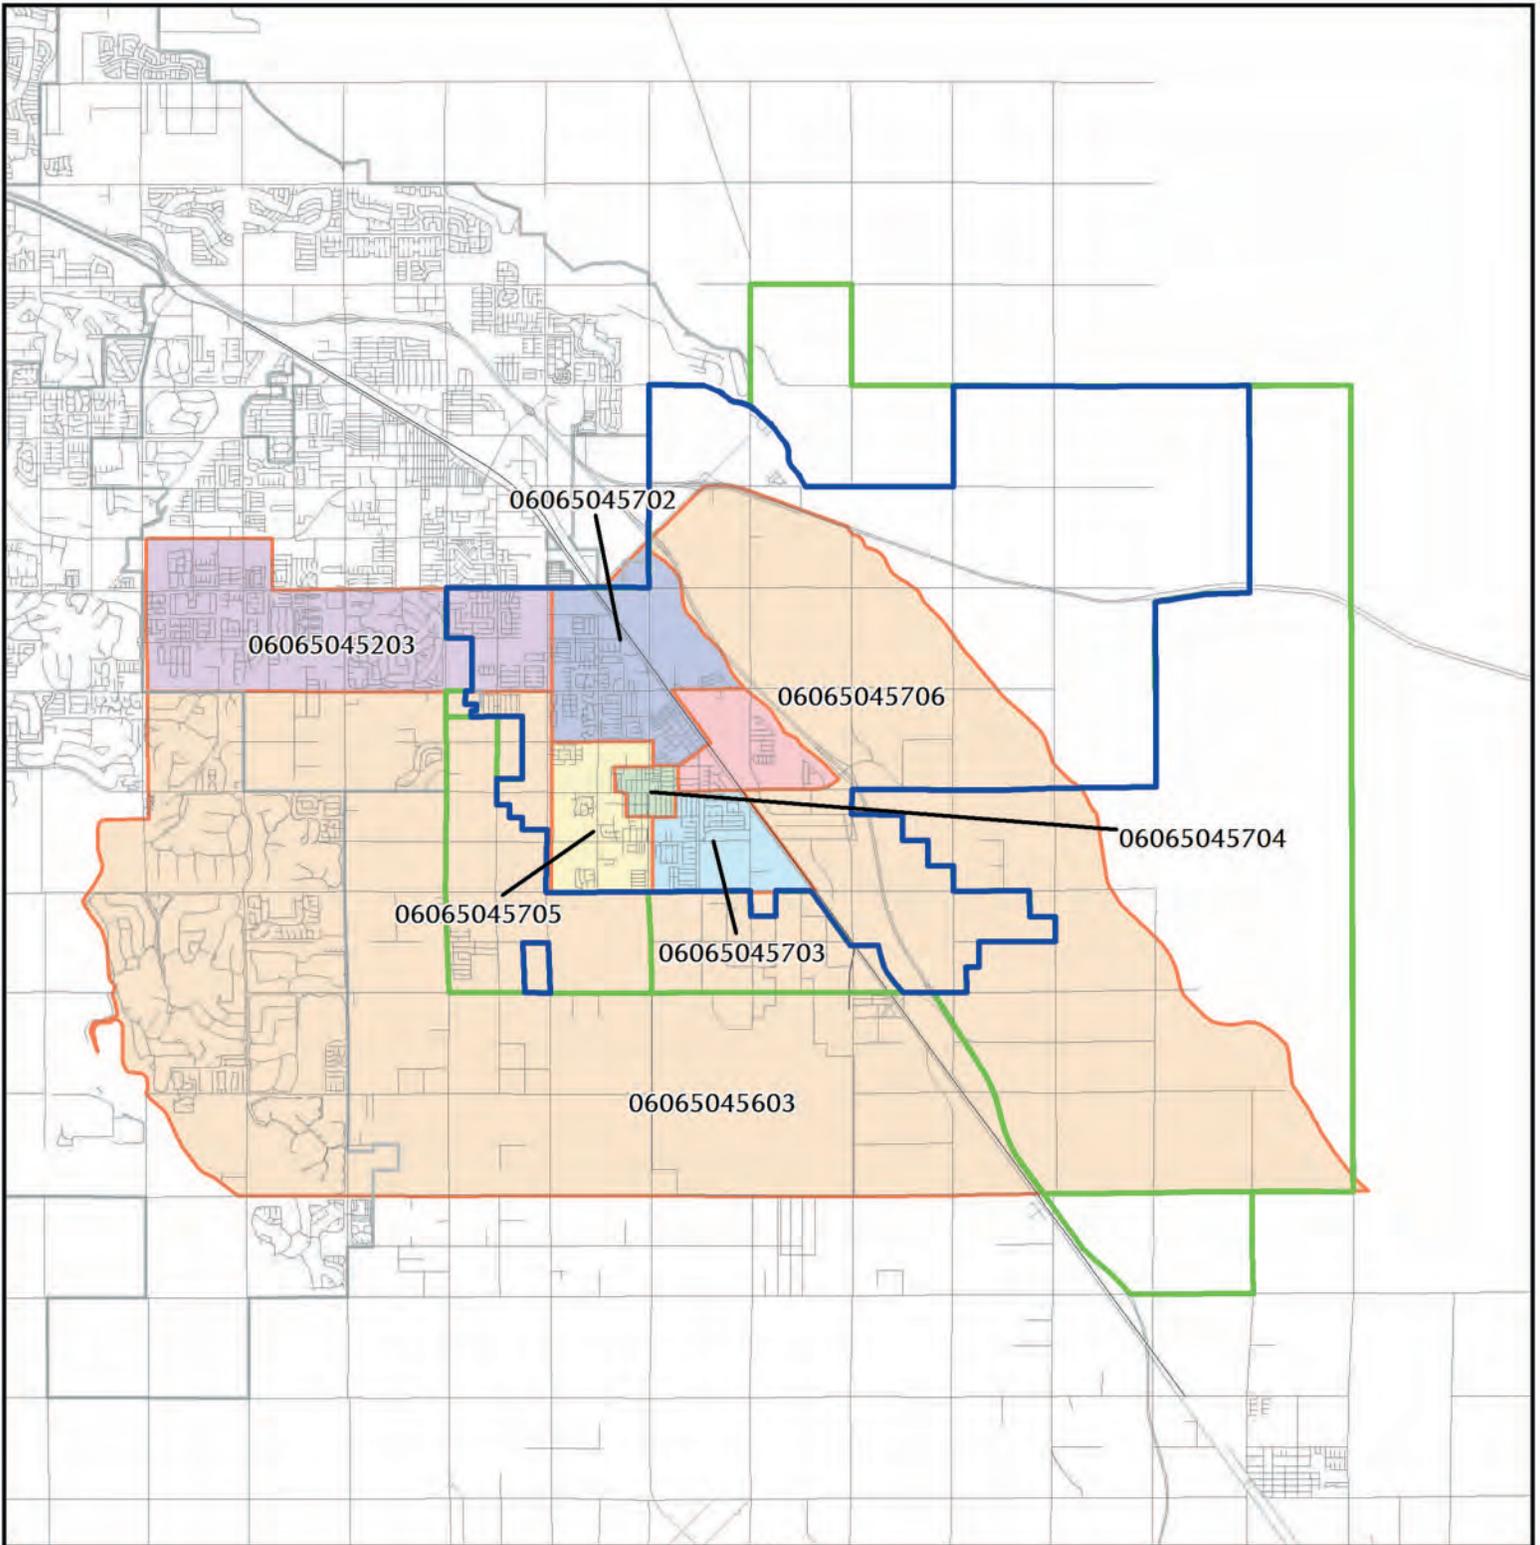
Figure 1-5

- 06065045603 Census Tract Boundaries with Census Tract Number
- Coachella City Boundary
- Coachella Planning Area Boundary

Census Tracts Used in the HazUS Analyses

HazUS relies on census data, which are reported by geographical areas or tracts. Unfortunately, census tracts often do not correlate well with city boundaries, especially in areas with low population densities. This is certainly the case for Coachella, where seven census tracts cover most, but not all of the General Plan area, and one of the census tracts considered also includes a large portion of the city of La Quinta to the west. The total area covered by these census tracts is 62.5 square miles (see Figure 1-5). Population counts were modified from those provided in the HazUS database (that date to the census of 2000) to incorporate the 2010 Census Data where available, and thus model the population increase that this area has experienced in the last decade. When the HazUS analyses for this study were conducted in July 2011, the U.S. Census Bureau had released population data for four of the seven census tracts considered (census tracts ending in 703, 704, 705 and 706, see Figure 1-5). These four tracts are entirely within the Coachella General Plan study area, and thus, the 2010 population numbers for these tracts were replaced in the HazUS database. The population counts from 2000 were kept for two of the remaining three census tracts (203 and 603) because a review of historical Google Earth

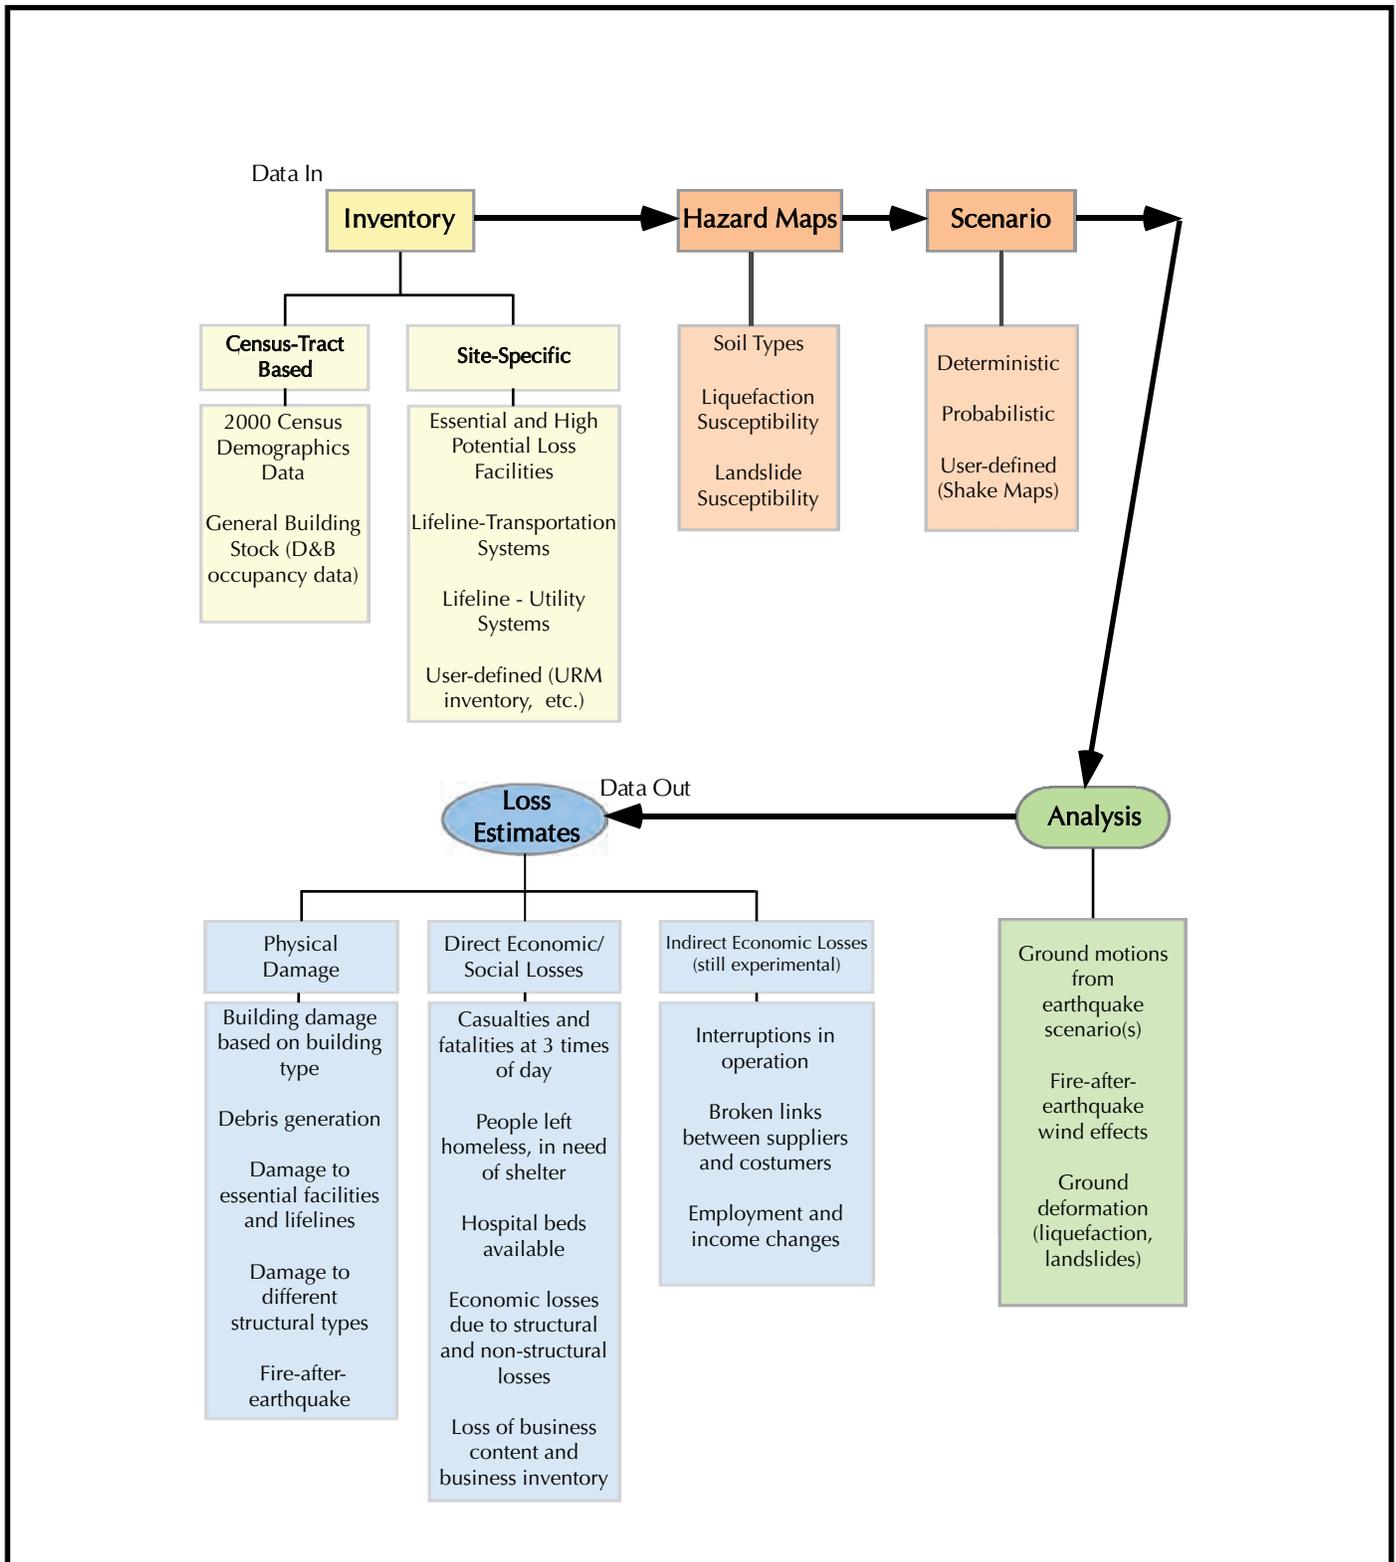
Figure
1-6

Generalized Flow Chart Summarizing the HazUS Methodology

Essential facilities and lifeline inventory are located by latitude and longitude. However, the HazUS inventory data for lifelines and utilities were developed at a national level and where specific data are lacking, statistical estimations are utilized. Particulars about the site-specific inventory data used in the models are discussed further in the paragraphs below. Other site-specific data used include soil types. The user then defines the earthquake scenario to be modeled, including the magnitude of the earthquake, and the location of the epicenter. Once all these data are input, the software calculates the loss estimates for each scenario (see Figure I-6).

HazUS is a regional multi-hazard loss estimation model developed by FEMA and the National Institute of Building Sciences. The primary purpose of HazUS is to provide a methodology and software application to develop multi-hazard losses at a regional scale. Local, state and regional officials can use these loss estimates to evaluate the area's vulnerability to multi-hazards and prepare for emergency response and recovery. Additional information regarding HazUS, including its uses and limitations, is provided in Chapter 1, Section 1.9. Unlike the earthquake analyses, where HazUS uses census tracts as the smallest areal unit of study, for flood analyses, HazUS uses census blocks. The geographical size of the region analyzed is nearly 62.5 square miles (see Figure 1-6); this region contains 521 census blocks (in 7 census tracts).

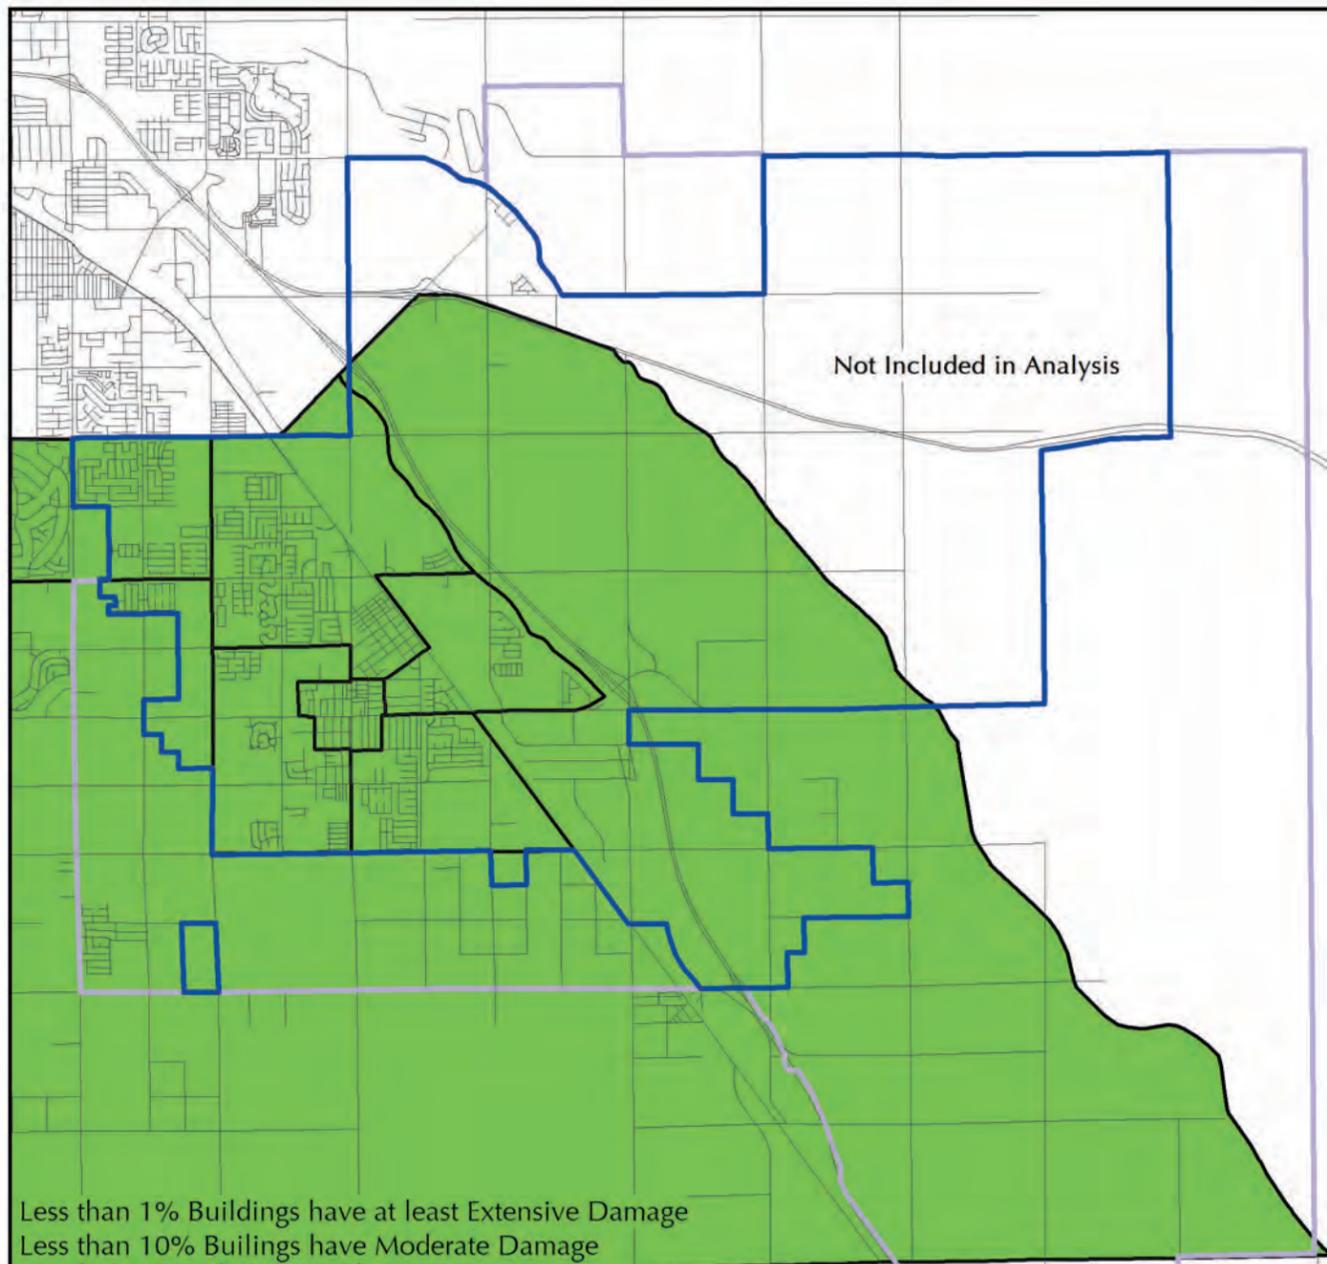
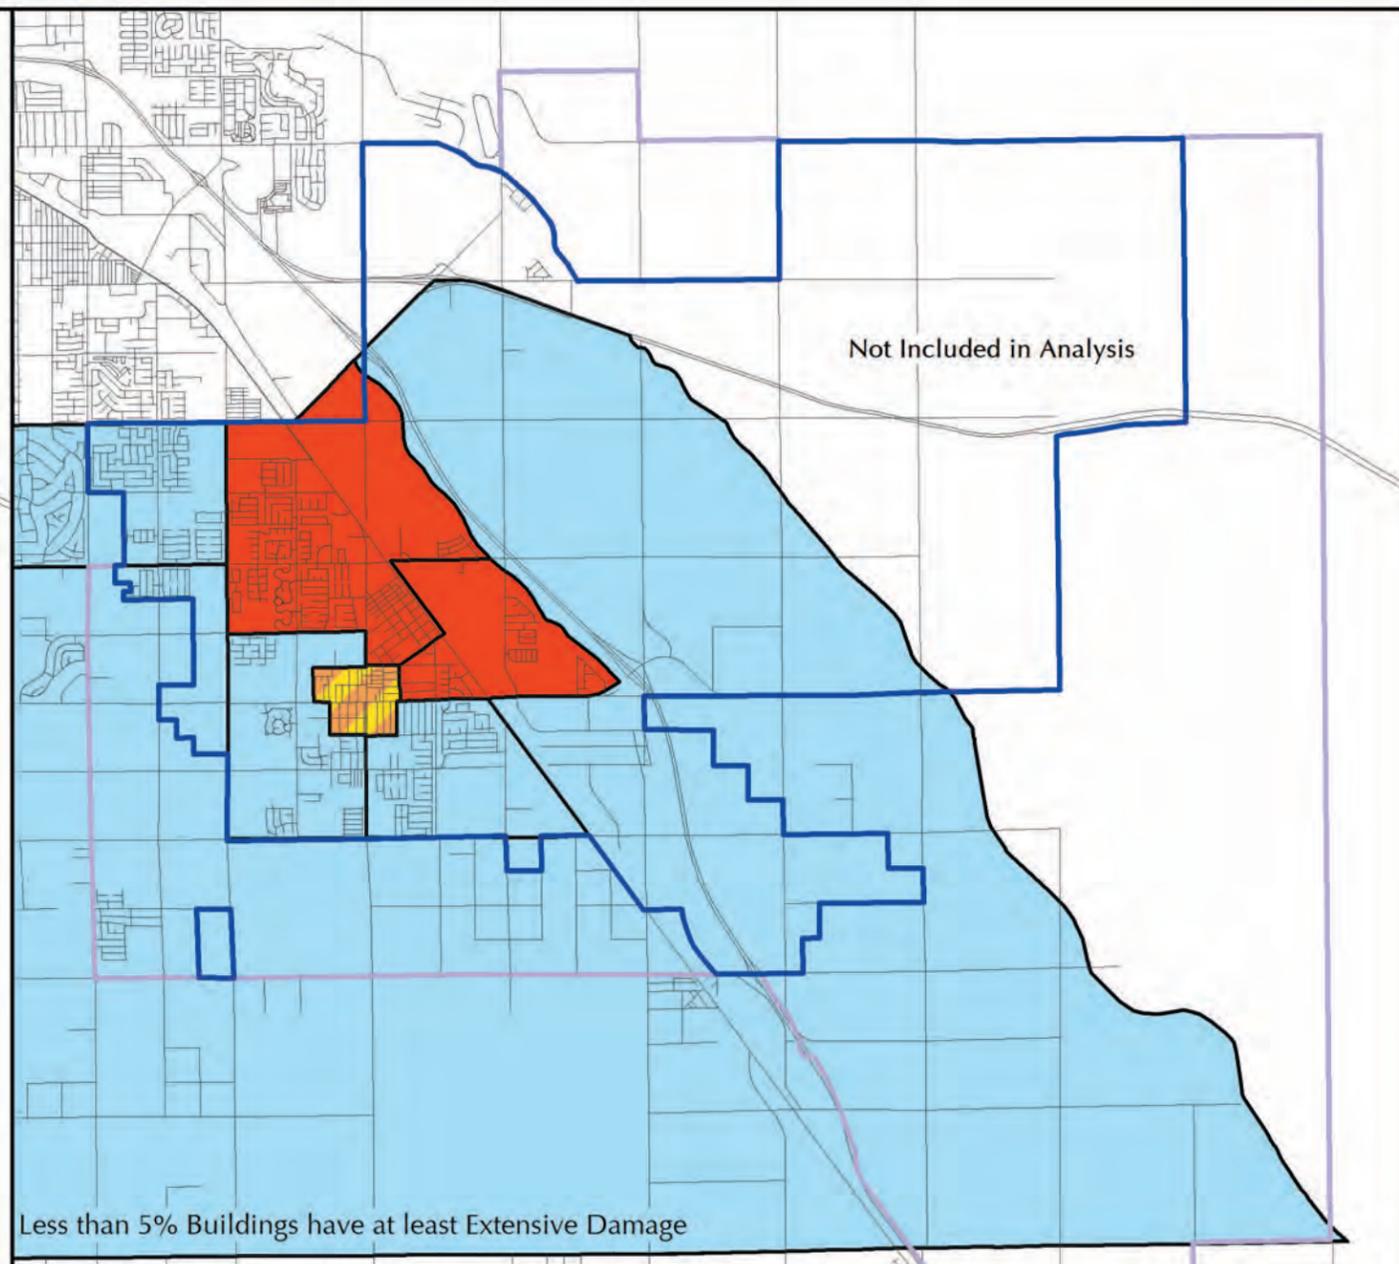
Less than 1% Buildings have at least Extensive Damage
 Less than 10% Buildings have Moderate Damage

Magnitude 7.1 Earthquake on Coachella Section of San Andreas Fault

Less than 5% Buildings have at least Extensive Damage

Magnitude 7.8 Earthquake on the Southern Sections of the San Andreas Fault (ShakeOut Scenario)

As a percentage of the building damage by occupancy type, the model estimates that more than 90 percent of the residential structures other than single-family homes (i.e., multi-family residential buildings, including duplexes, condominiums and apartments) will suffer at least moderate damage from a M7.8 earthquake on the San Andreas fault. The distribution and severity of the damage to residential structures by census tract as a result of the two

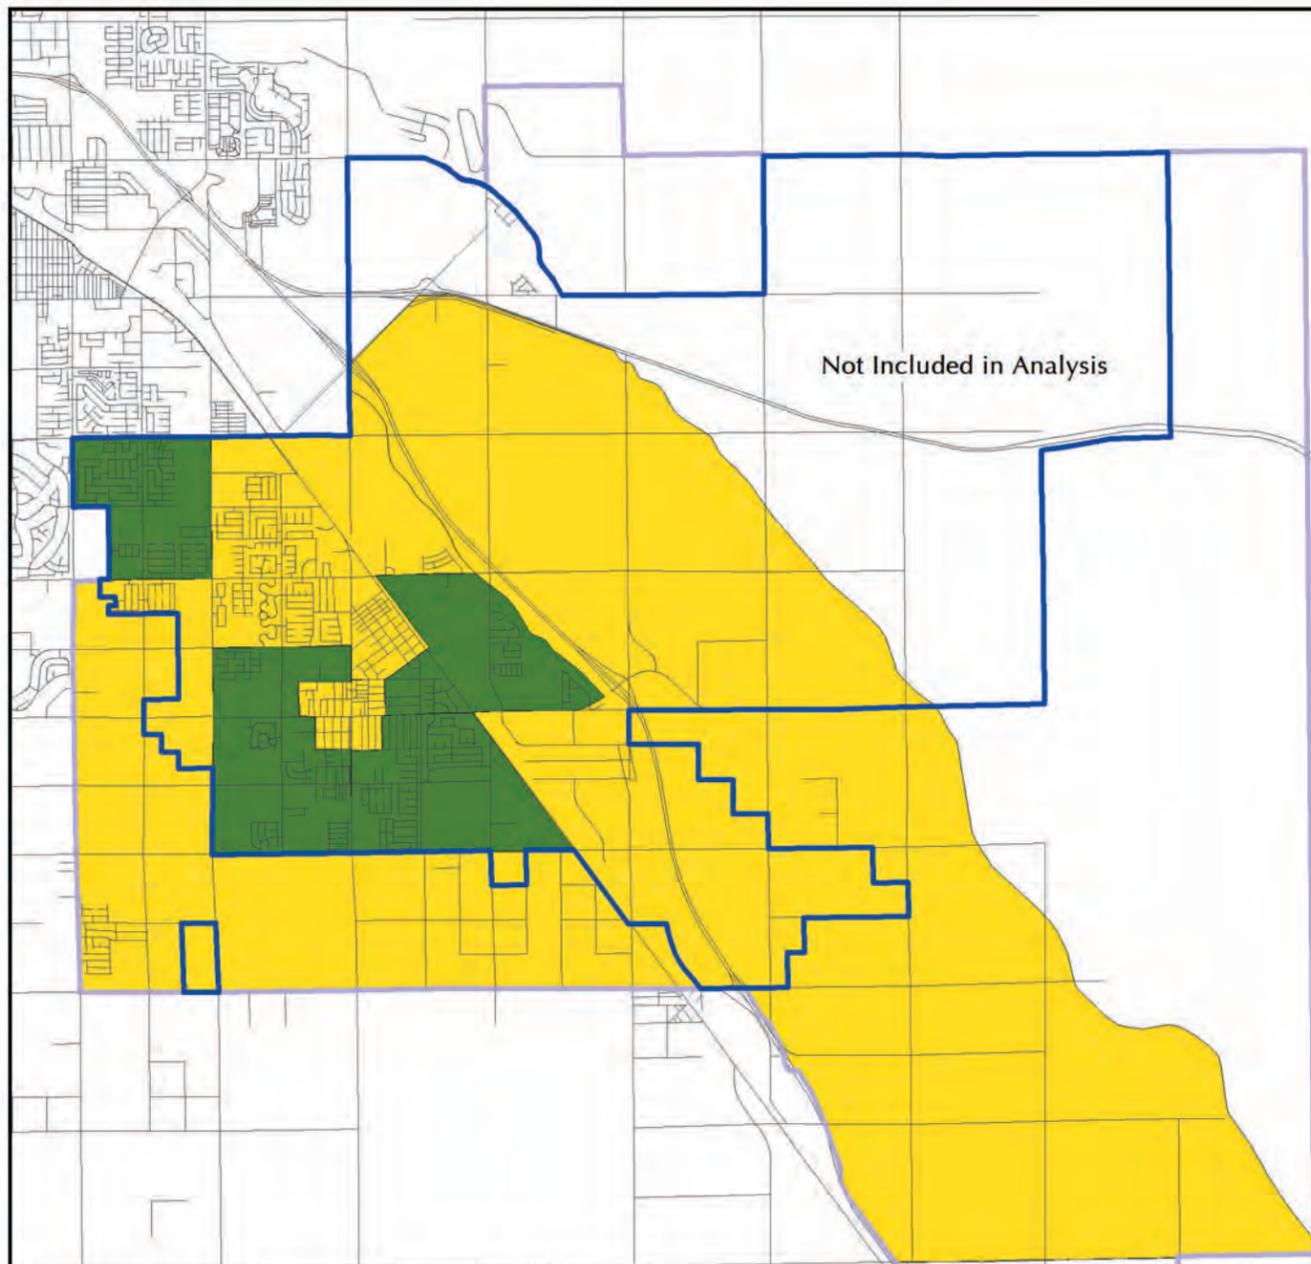
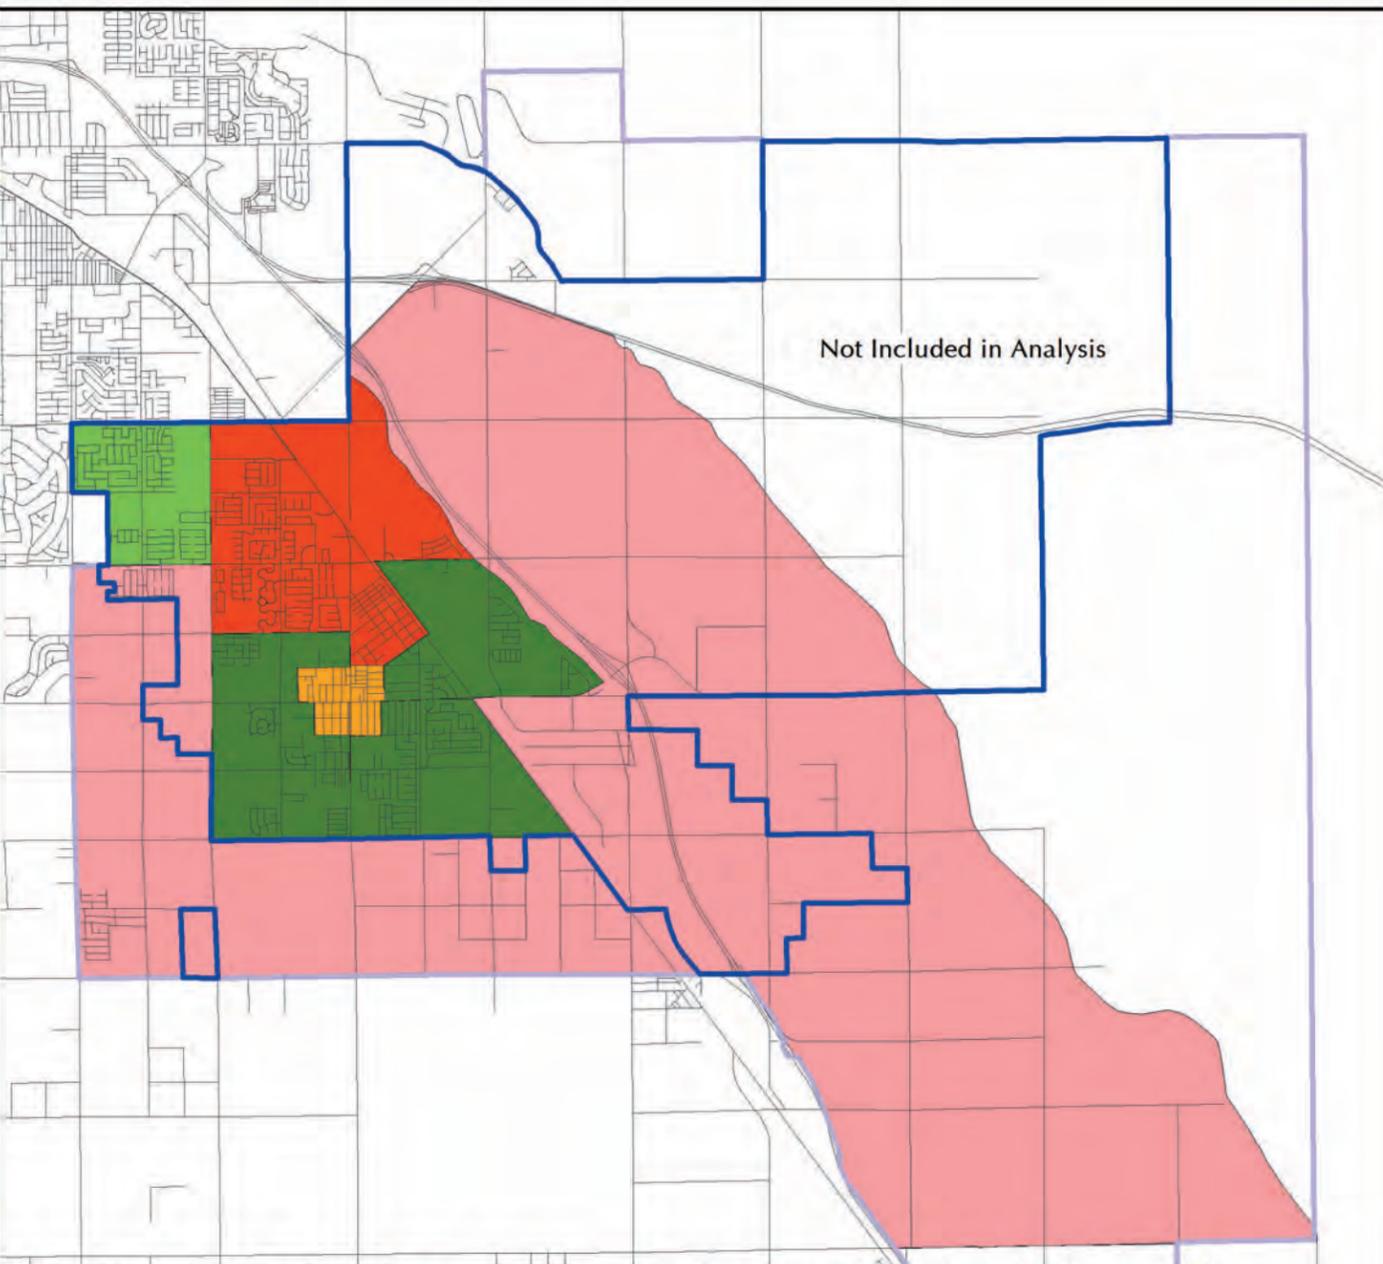
Plate
1-6

Commercial and Industrial Loss
(Based on Two Earthquake Scenarios)
Coachella, California

Magnitude 7.8 Earthquake on the Southern Sections of the San Andreas Fault (ShakeOut Scenario)

Magnitude 7.1 Earthquake on Coachella Section of San Andreas Fault

The distribution of economic losses to buildings of different types in the city of Coachella by census tract as a result of the two earthquake scenarios considered are illustrated in Plates I-5 (Residential), I-6 (Commercial and Industrial), and I-7 (Schools). All of these graphics show that a M7.8 earthquake on the entire southern section of the San Andreas fault will be significantly more damaging to Coachella than a M7.1 earthquake on only the Coachella segment of the fault. Furthermore, Plate I-5 shows that the largest economic losses to residential buildings can be expected in the older, more-densely occupied sections of the city, where there is a higher concentration of pre-1980s structures. Economic losses associated with the damage to commercial and industrial facilities (Plate I-6) are partly constrained by the age and density of these types of structures in the city (like the residential stock described above), but are also dictated by the location of these facilities relative to the San Andreas fault. Thus, given that there are many industrial facilities along the eastern portion of the city, adjacent to the fault, the census tract where these facilities are located shows significant economic losses, especially as a result of the M7.8 earthquake scenario. Similarly, the losses estimated for school buildings (Plate I-7) are defined in great part by the age of the structures, and the schools' locations relative to the San Andreas fault. The highest losses anticipated as a result of damage to school buildings are expected in the center of the city, where the oldest schools are located, seconded by the losses in the census tract closest to the San Andreas fault.

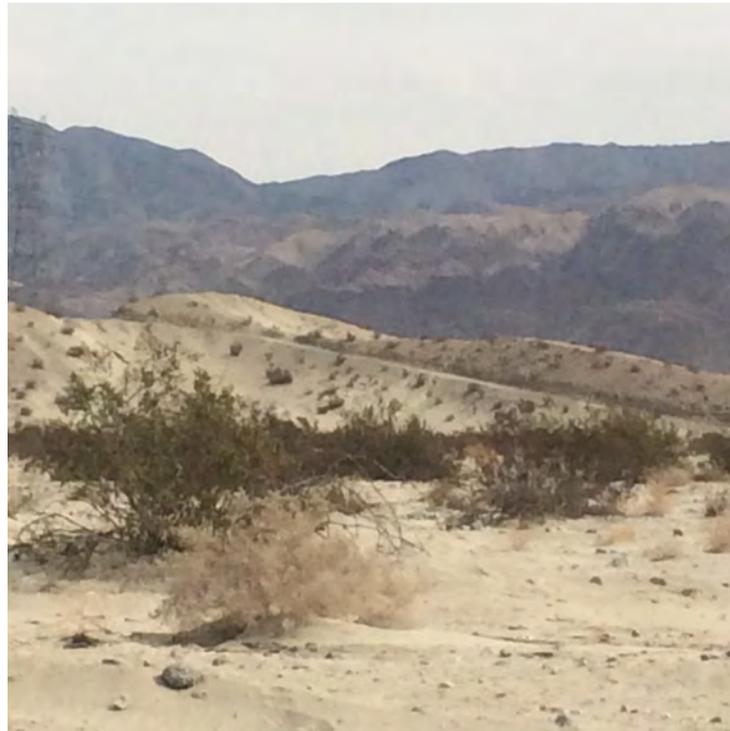
Figure 2-1: Geologic Units in the Coachella Area. The sands in the foreground are alluvial deposits reworked by the wind; the hills in the middle are comprised of the Upper Ocotillo Conglomerate, whereas the mountains in the far distance consist of crystalline rocks.

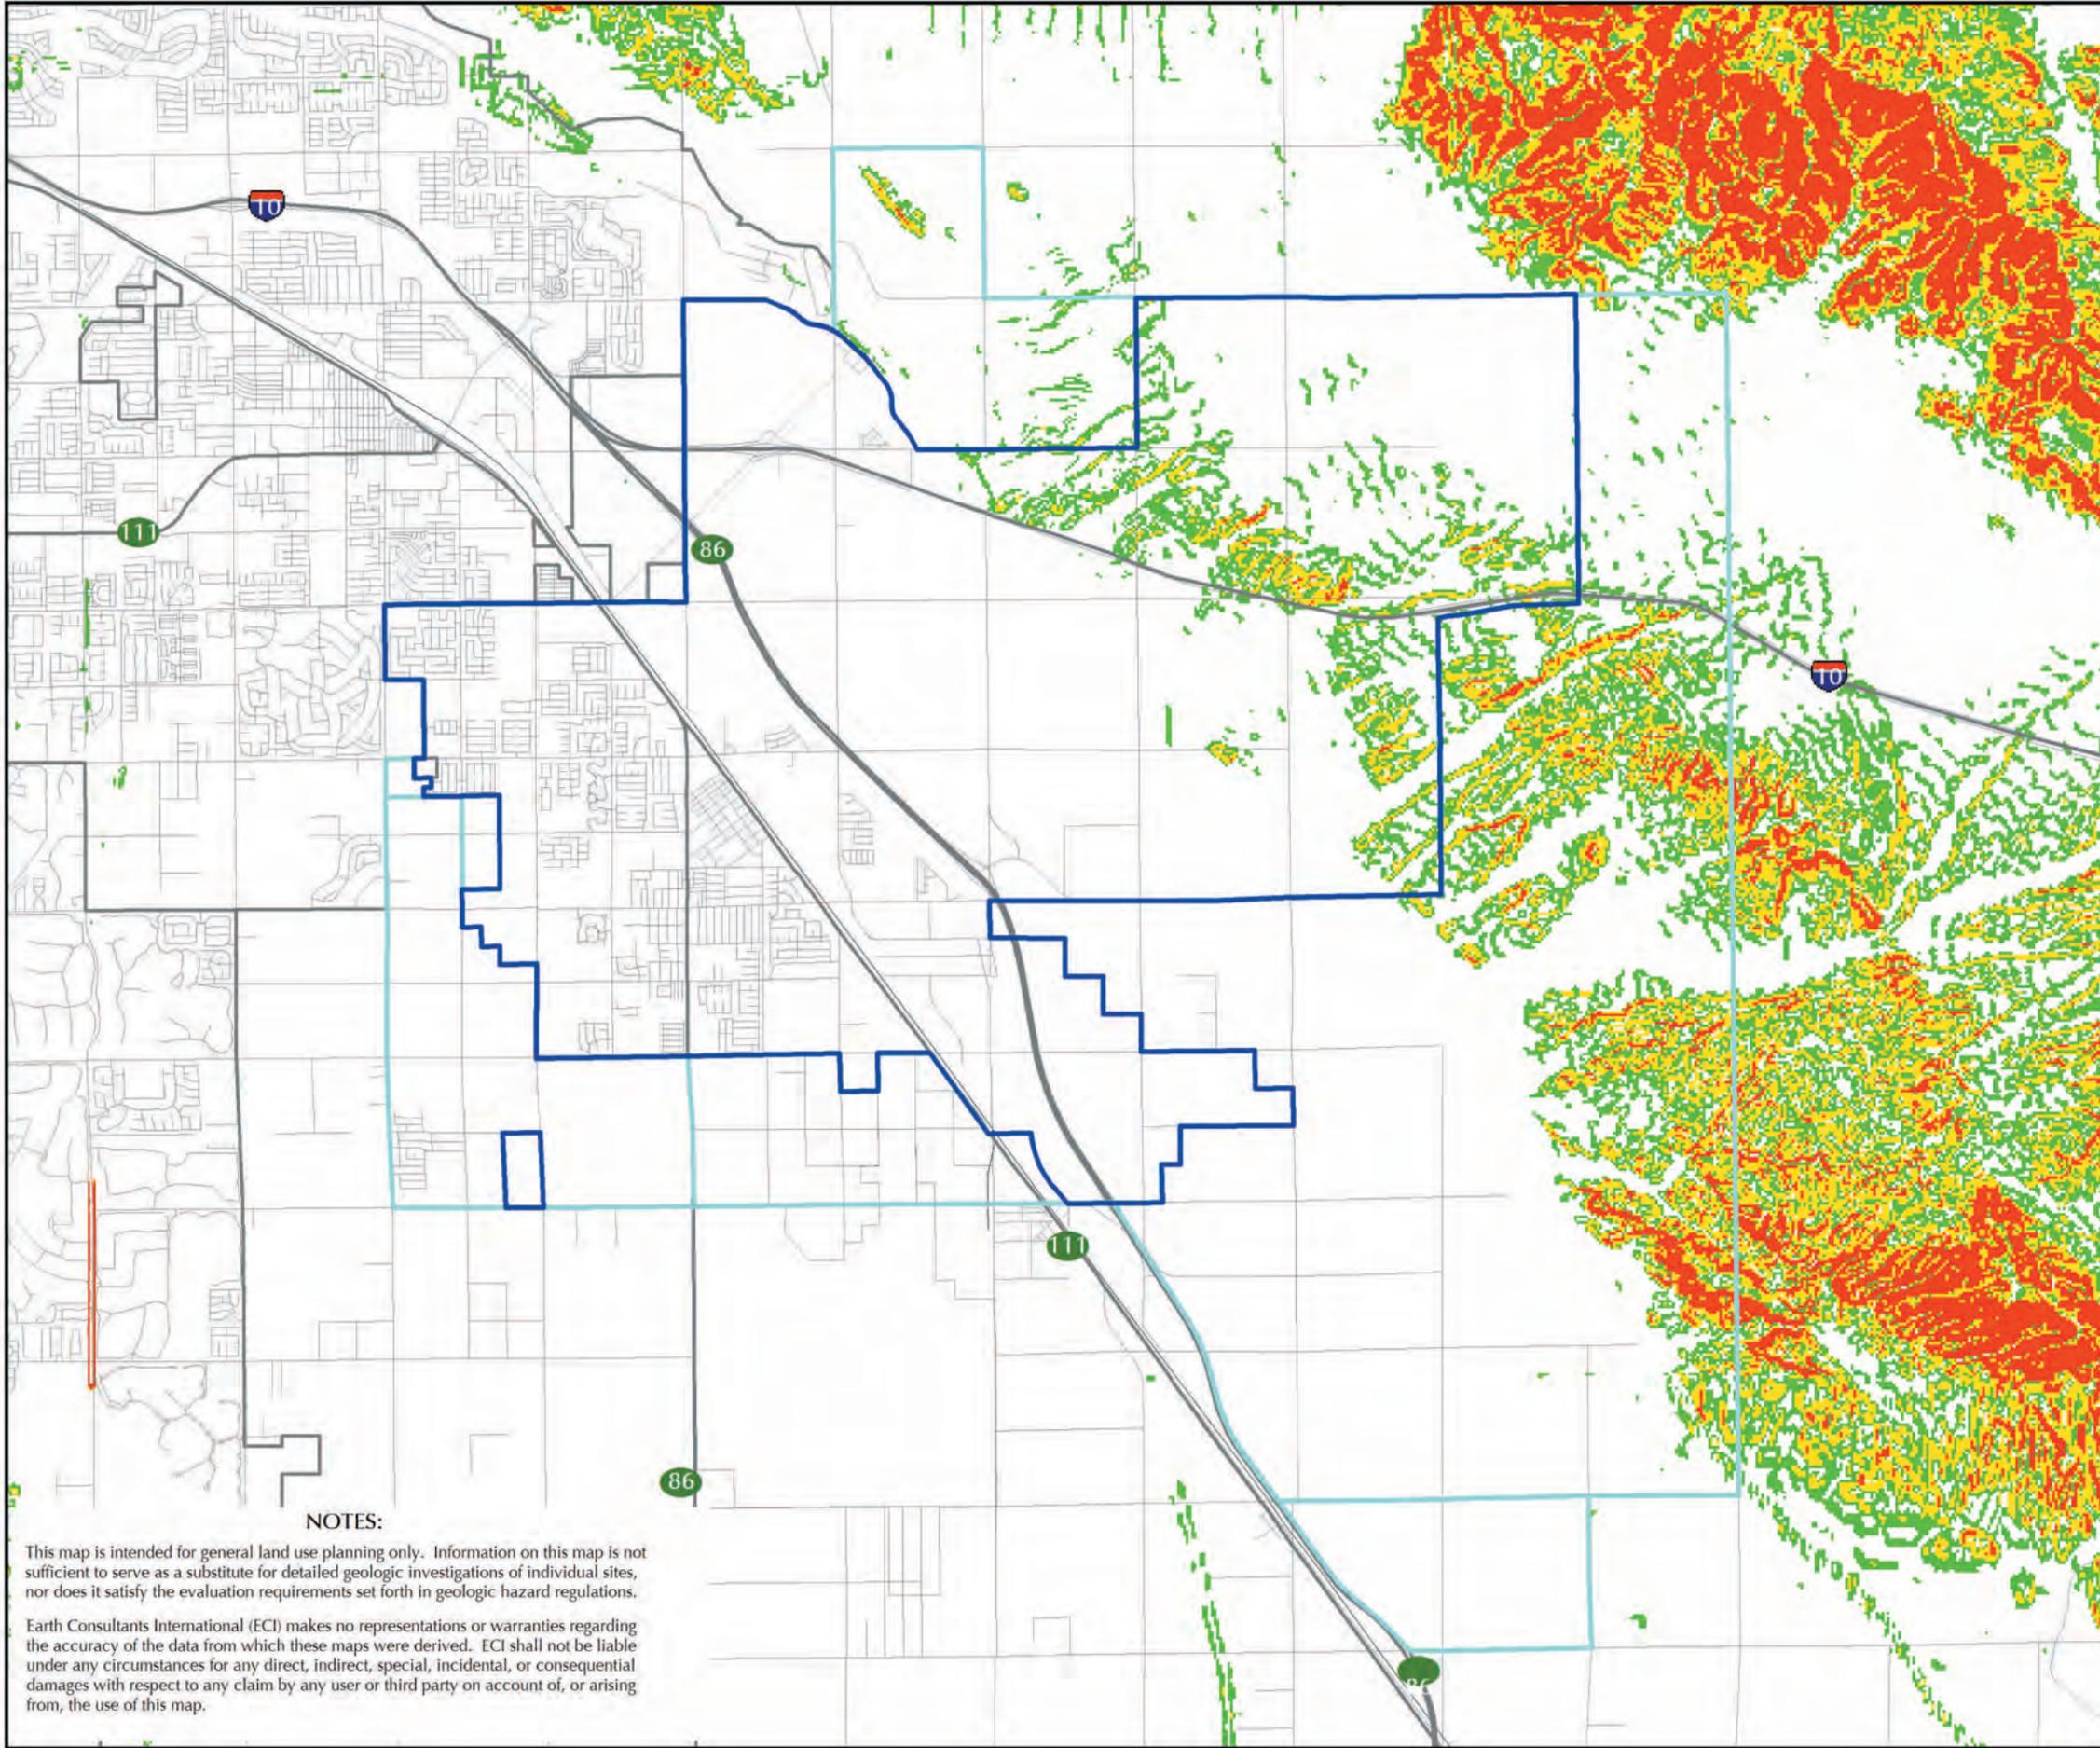
Slope Distribution Map

Slopes within this range of gradients are present in the higher hills and mountains within and above the Coachella General Plan area (see Plate 2-2).

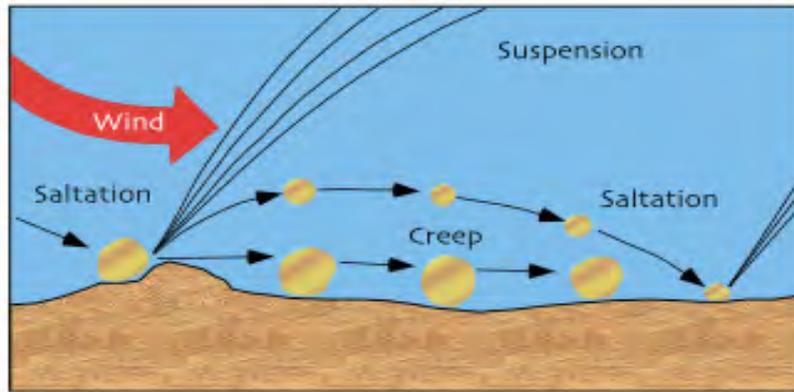
Figure 2-2: Wind-Induced Soil Movement

Soil movement is initiated as a result of wind forces exerted against the surface of the ground. For each specific soil type and surface condition, there is a minimum velocity required to move soil particles. This is called the threshold velocity. Once this velocity is reached, the quantity of soil moved is dependent upon the particle size, the cloddiness of the particles, and the wind velocity itself. Suspension, saltation, and surface creep are the three types of soil movement that occur during wind erosion (Figure 2-2). While soil can be blown away at virtually any height, the majority (over 93 percent) of soil movement takes place at or within one meter (3 feet) of the ground surface.

Wind-induced soil movement is initiated as a result of wind forces exerted against the surface of the ground, and includes suspension, saltation, and surface creep. Soil can be blown high into the atmosphere; however, most soil movement takes place at or within one meter of the ground surface.
