**Appendix A:
REFERENCES and USEFUL WEBSITES**

I.2.2 Seismic Hazards Mapping Act

Active and Potentially Active Faults

Within about 50 miles of Coachella, California

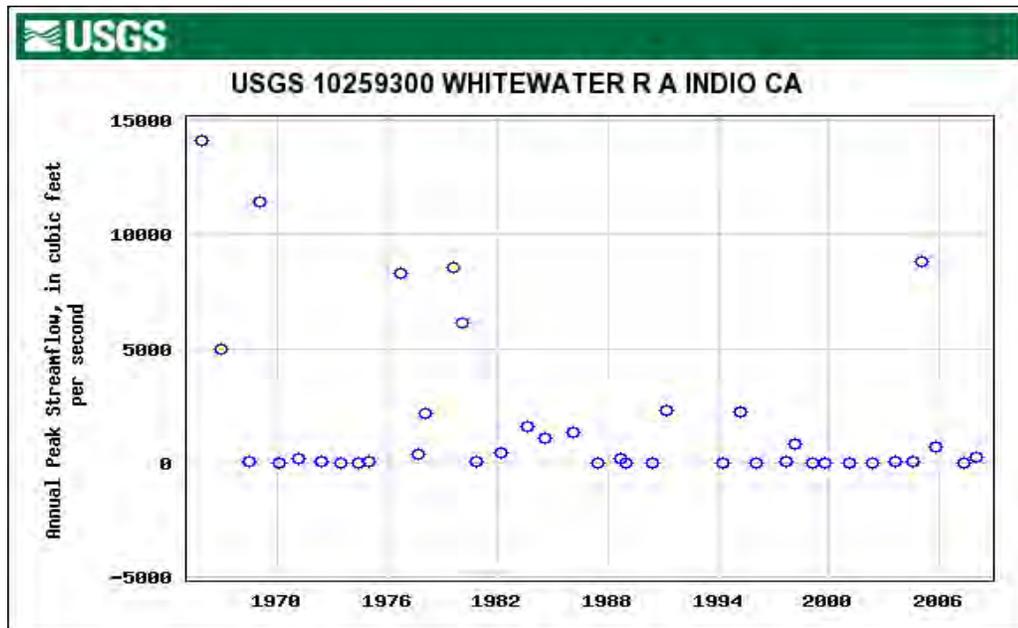
Figure 3-1: Peak Annual Streamflow Values for Gage Station USGS 10259300 Located on the Whitewater River in Indio, Near Coachella

Not only does rainfall in southern California vary from one location to the next, often within short distances, it is also extremely variable from year to year, with periods of drought alternating with periods of flooding. For instance, annual rainfall totals are illustrated in the peak streamflow graph for a gage on the Whitewater River (see Figure 3-1). This gage, located at the Southern Pacific Railroad Crossing in Indio, has recorded the extreme fluctuations in stream discharge that occurred in the area over a 42-year period (1966-2008) that, given its location, best represents the conditions that have occurred and can occur in Coachella. With peaks

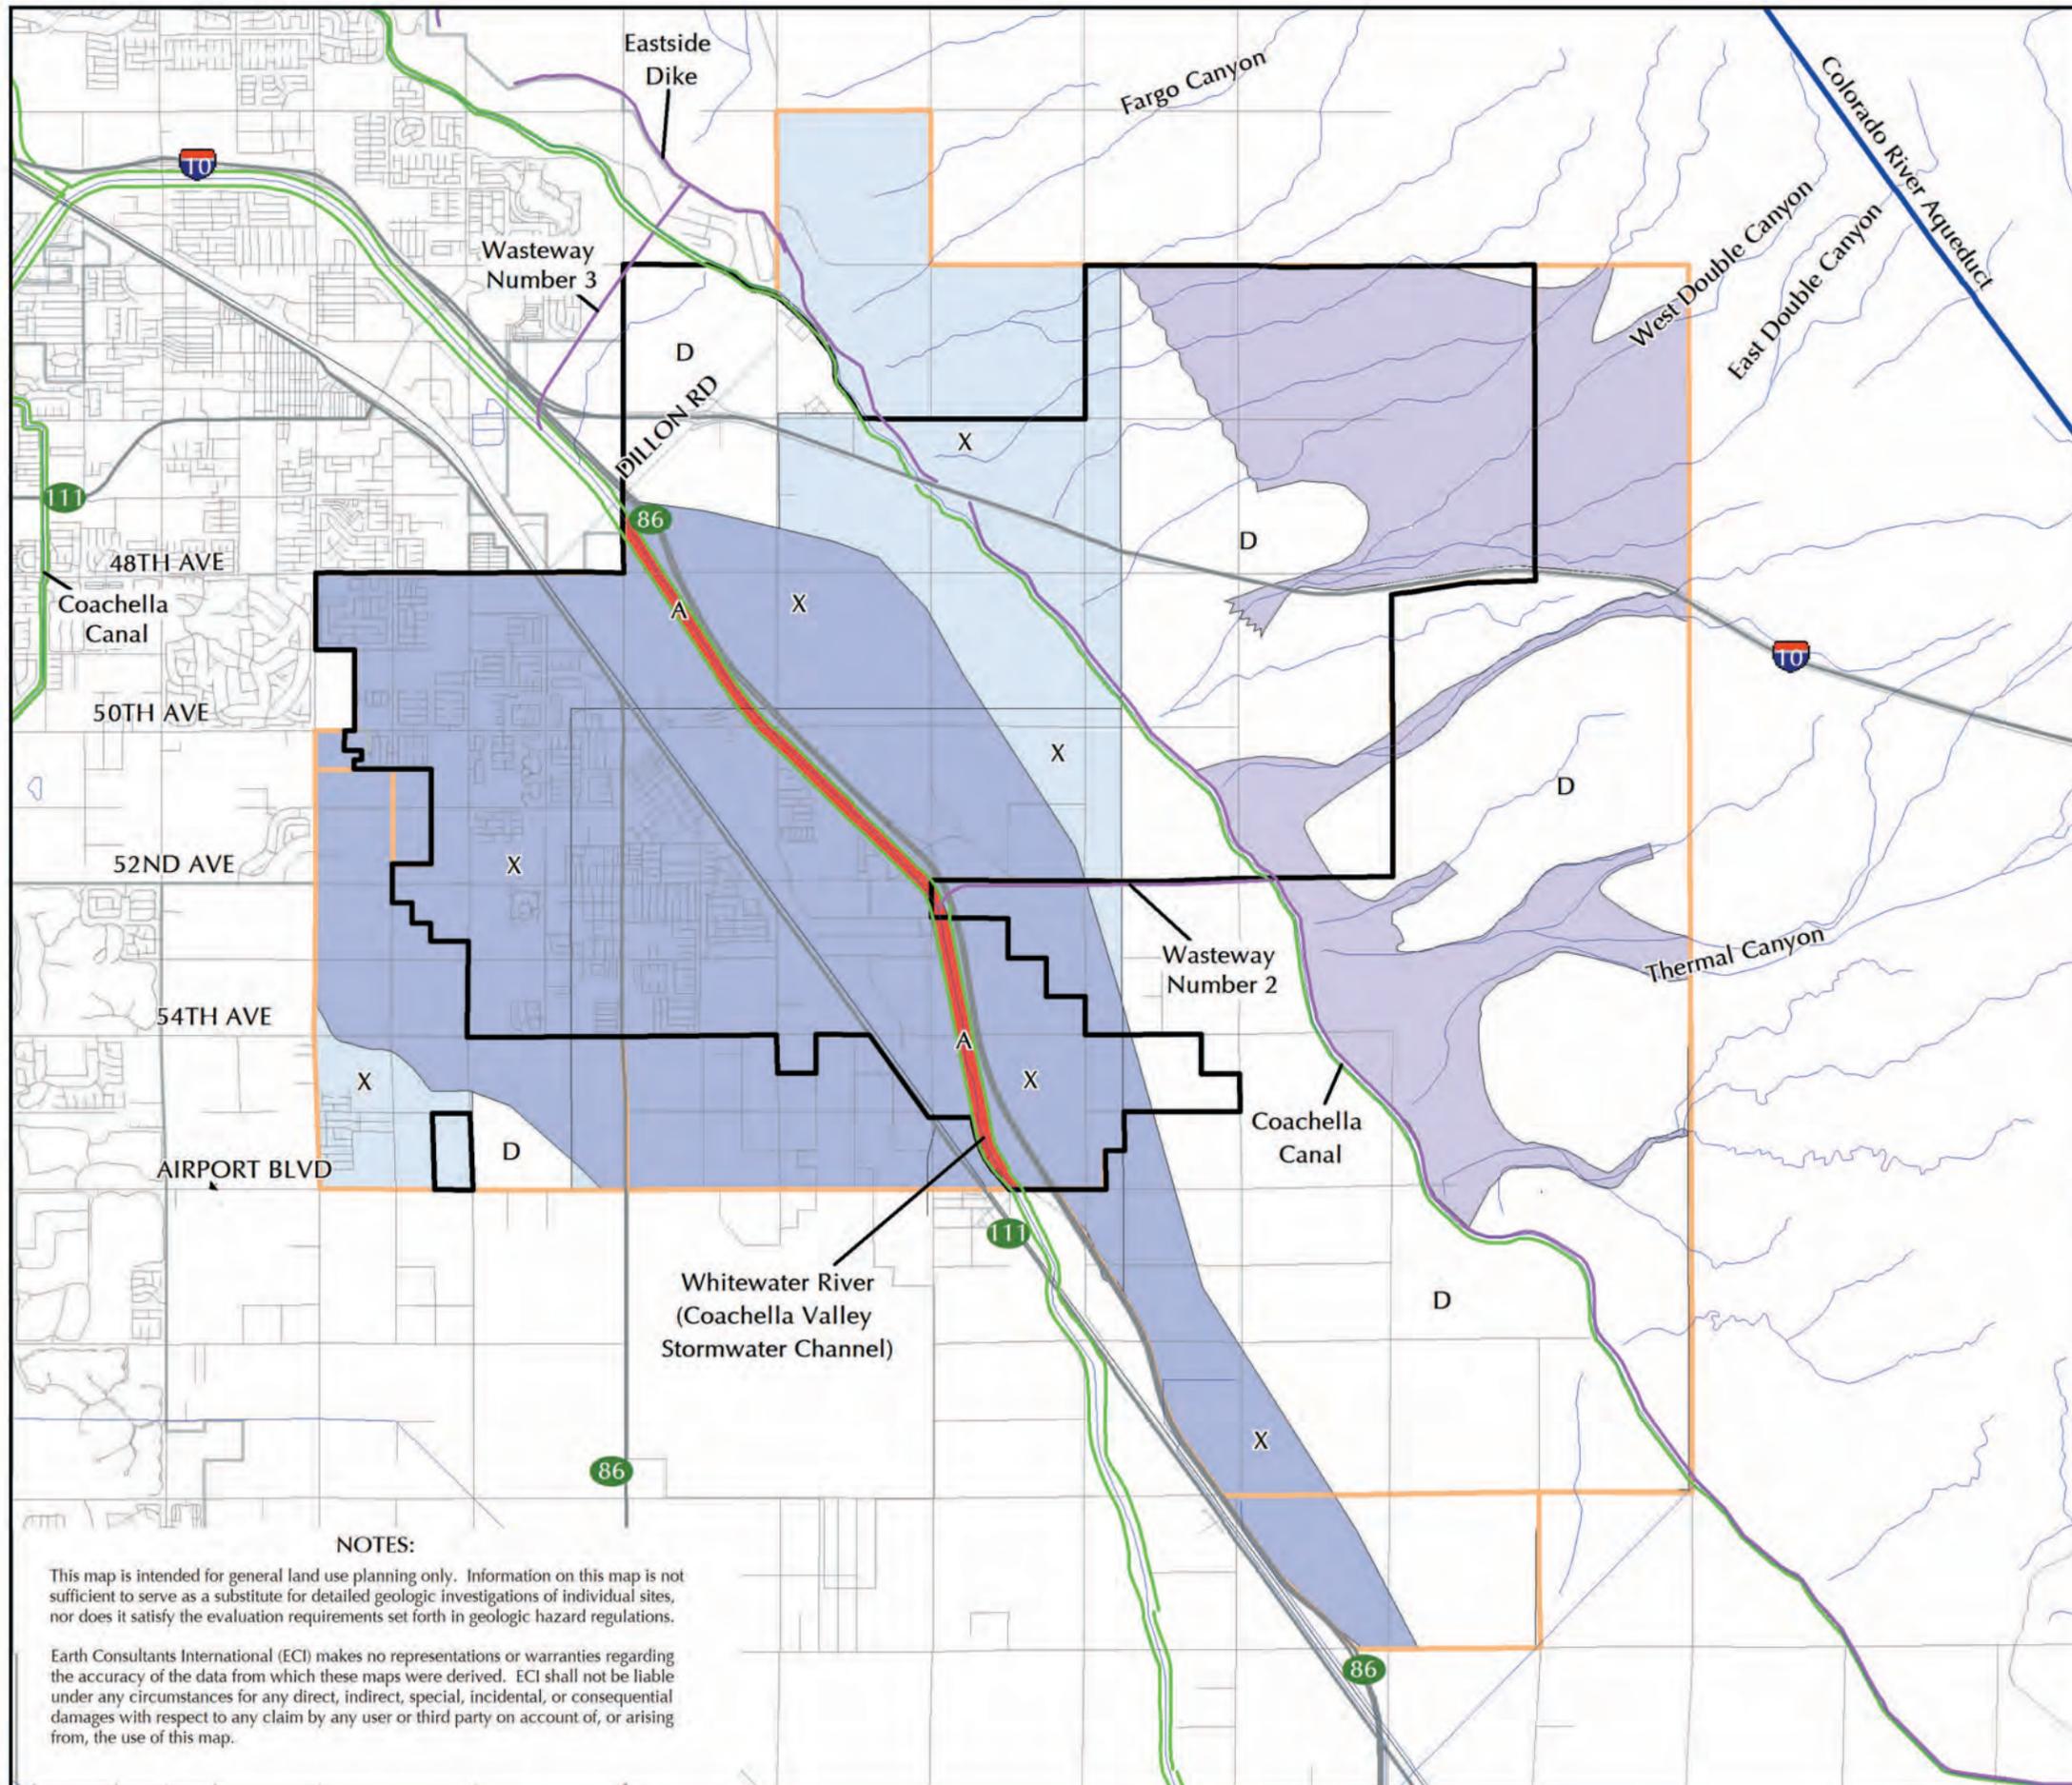
As part of the National Flood Insurance Program, the potential for flooding in portions of the Coachella General Plan area has been analyzed through the Flood Insurance Study for Riverside County (FEMA, 2008a). The potential flood zones mapped by FEMA are published in Flood Insurance Rate Maps that were updated in 2008. The current FEMA flood zones for the General Plan area are illustrated on Plate 3-1. According to the FIRMs, the Coachella Valley Stormwater Channel (Whitewater River) is the only part of the General Plan area that is classified as a 100-year flood zone.

Flood control facilities in the Coachella area are briefly described below and major regional structures are identified on Plate 3-1.

Levees constructed of large sandpiles with no reinforcement occur along both sides of the channel (see Plate 3-1). The levees are easily eroded and require periodic maintenance. According to the most recent (August 2008b) FIRMs, and the CVWD, the levees along the Whitewater River that protect Coachella from the 100-year flood are currently not accredited. Detailed hydraulic analyses, based on the new FEMA procedures, were performed by the CVWD for the reach extending from the Monroe Street bridge (in the city of Indio) to the Salton Sea. The result of these analyses indicated areas adjacent to channel, from just north of Airport Boulevard (Avenue 56) to the south, are susceptible to inundation from a levee breach

The flood analysis was conducted using a digital version of the 500-year flood zone shown on the Flood Insurance Rate Map presented on Plate 3-1 as a "user-supplied hazard" that was converted to a HazUS compatible format. We used HazUS to generate building stock and essential facility loss estimates for a 0.2 percent annual chance flood event (500-year flood) on the Whitewater River, with average water depths of 1 foot. The 500-year flood was chosen because the 100-year flood event would be mostly confined to the channel of the Whitewater River, whereas the 500-year flood event, while a lot less likely, would impact a significant part of the community. The results of the analysis are presented in the sections below.

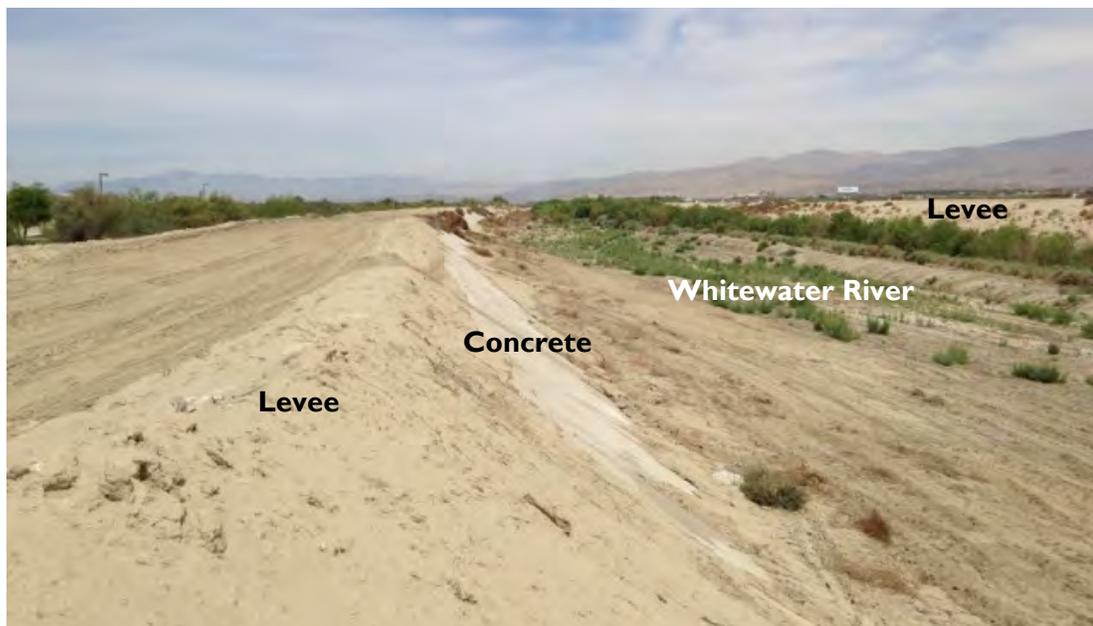
The Whitewater River's course through Coachella is confined to this broad, soft-bottom channel. The western bank of the channel is reinforced with concrete north of Avenue 54.

This view, looking north from Avenue 50, shows the sand levees along the channel and concrete facing on the western bank.

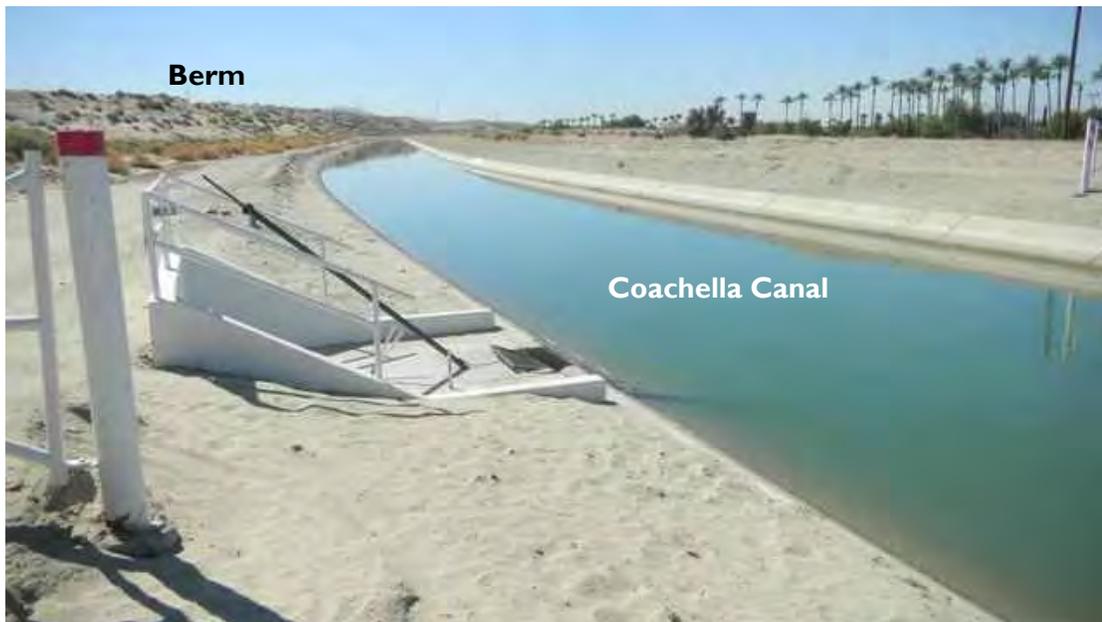
Figure 3-3: Coachella Canal and Eastside Dike.

Eastside Dike: The Bureau of Reclamation constructed the Eastside Dike in the 1940s to protect the Coachella Canal by detaining runoff from the Mecca Hills, Indio Hills, and Little San Bernardino Mountains, and diverting it to the Coachella Valley Stormwater Channel (thereby protecting the valley area as well). North of Interstate 10, the earthen dike is located northeast of the canal, where it forms a detention basin with a capacity of 21,000 acre-feet. South of Interstate 10, the dike lies adjacent to the east side of the canal, forming a detention basin with a capacity of 18,000 acre-feet (Coachella Valley County Water District, 1967). In the city of Coachella area, two inlet structures allow water detained behind the dike to reach the Stormwater Channel via open, concrete-lined diversion channels. One of the channels is located at the northern edge of the General Plan area (Wasteway No. 3, see Plate 3-1), and one is present in the central part of the area, running parallel to Avenue 52 (Wasteway No. 2). The Eastside Dike and its diversion channels are maintained by the Coachella Valley Water District. The District is currently implementing plans to repair the wasteway channels in order to facilitate the flow of stormwater impounded behind the dike during floods, and to provide a way to drain the Coachella Canal during an emergency.

The Eastside Dike, the earthen berm shown in the upper left corner of the photo, protects the Coachella Canal from stormwater flowing out of the nearby hills and mountains.

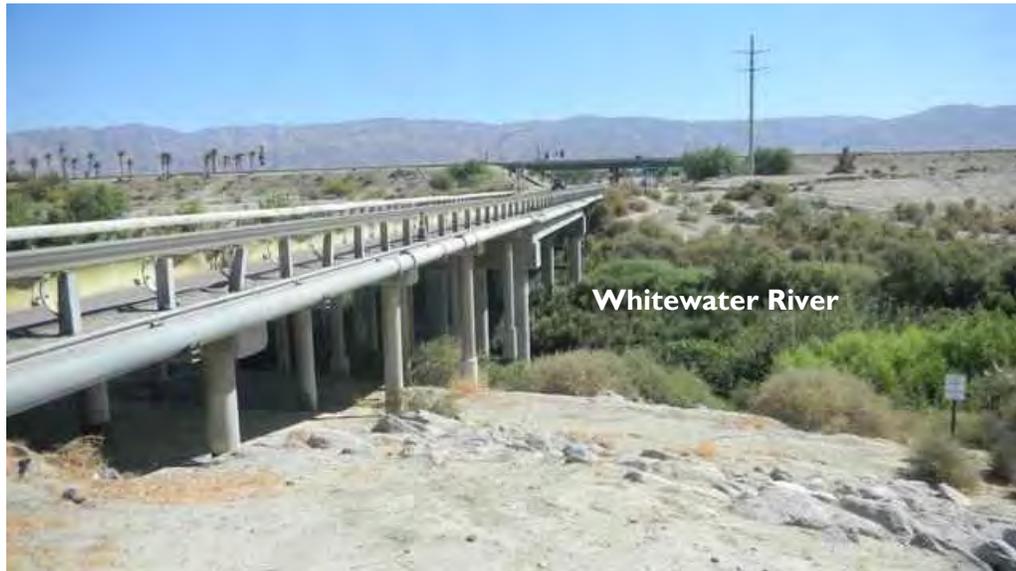
**Figure 3-4: Bridge Crossing the Coachella Valley Stormwater Channel
(Whitewater River) at Dillon Road**

Dillon Road, Avenue 50, Avenue 52, and Airport Boulevard (Avenue 56) are Coachella's only crossings of the Coachella Valley Stormwater Channel. Except for Avenue 50, these crossings consist of bridges over the channel. The roadway for Avenue 50 dips into the channel and is impassable when the channel is flooded. Highway 111 (Grapefruit Boulevard) and the Southern Pacific Railroad tracks cross the channel just south of Coachella. In December 1966, one of the most damaging storms on record hit the valley. Although water remained within the channel banks, the channel bed from Airport Road south to Avenue 60 was scoured so deeply it caused damage to the Airport Road bridge, threatened the stability of Highway 111, and exposed about three feet of the pile footing under the railroad bridge piers (Coachella Valley County Water District, 1967). Again, in January-February of 1969, a series of strong storms damaged roads, storm channel crossings and railroad bridges. The rail bridge and Highway 111 bridge south of Thermal were washed out, as was the Airport Road bridge just east of Thermal. In fact, between Palm Springs and the Salton Sea, the only usable crossings remaining were the Highway 86 (Indio Boulevard) bridge and the rail crossing west of Indio. It is thus very important that these crossings continue to be inspected by the City's Public Works Department, during and after flooding, for obstructions and potential scour damage.

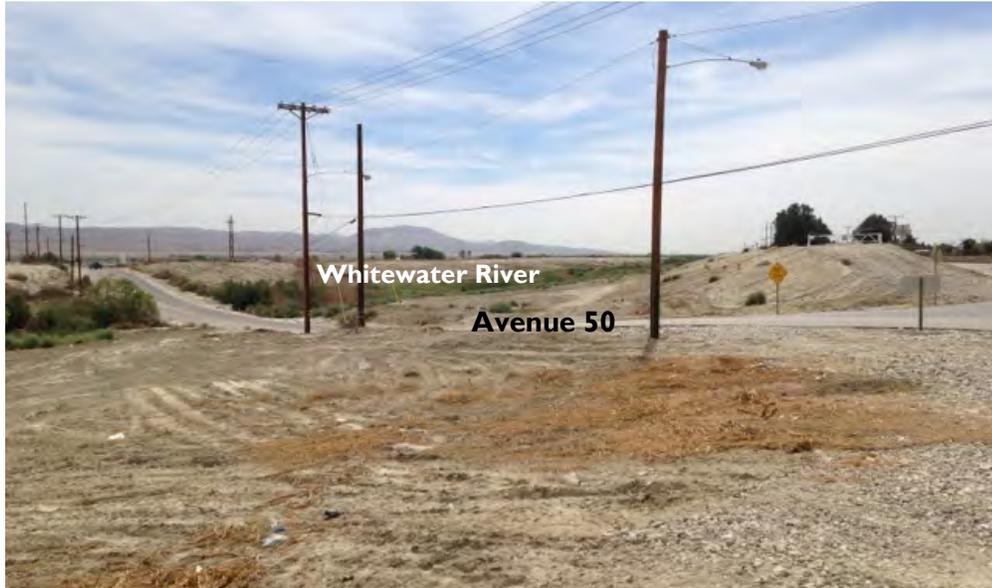
Figure 3-5: Proposed Location of New Bridge.

The city's current Capital Improvement Program includes a new bridge which will replace the dry weather crossing at Avenue 50. This will allow another safe crossing of the channel during storms.

The city of Coachella is currently planning a bridge for the Avenue 50 dry-weather crossing.

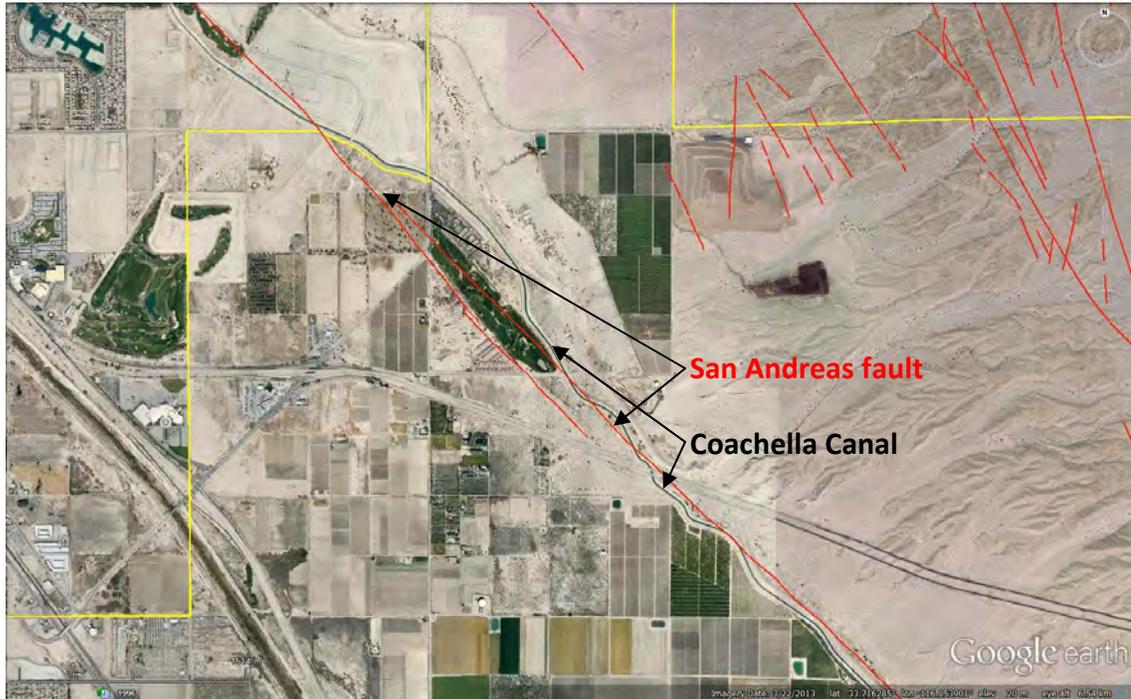
Within the City, the Coachella Canal is especially vulnerable to primary fault rupture, as its alignment nearly coincides with the trace of the San Andreas fault – a condition considerably more severe than a high-angle fault crossing (see Figure 3-6 and Chapter 1, Section 1.5). The 2008 USGS ShakeOut Scenario estimates that rupture by offset of the canal would likely occur

in at least three places, resulting in flooding of valley areas to the southwest. Immediate offset could be on the order of 7.2 to 15.7 feet (2.2 to 4.8 meters), with an additional afterslip of 5.9 to 10.8 feet (1.8 to 3.2 meters), which is likely to hamper repairs of the damaged canal (Jones et al., 2008).

Figure 3-6: Crossings of the Coachella Canal by the San Andreas Fault.
Faults in red. Compare this Figure with Plate 1-2.

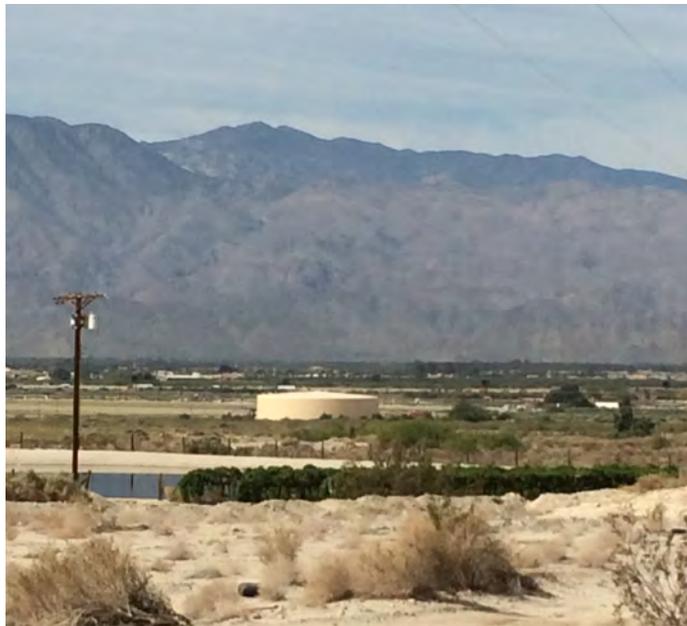
Figure 3-7: View of One of the Above-ground Water Tanks in the Coachella General Plan Area

The City of Coachella has three above-ground water reservoirs in the General Plan area. The newest tank, located at Well 18, is the only one constructed to current seismic standards. All tanks have isolation valves. The only above-ground reservoir in the Coachella General Plan area owned by the Coachella Valley Water District is located in their Coachella yard. It is an older tank that has not been retrofitted. The District is currently evaluating whether to upgrade or demolish the facility.

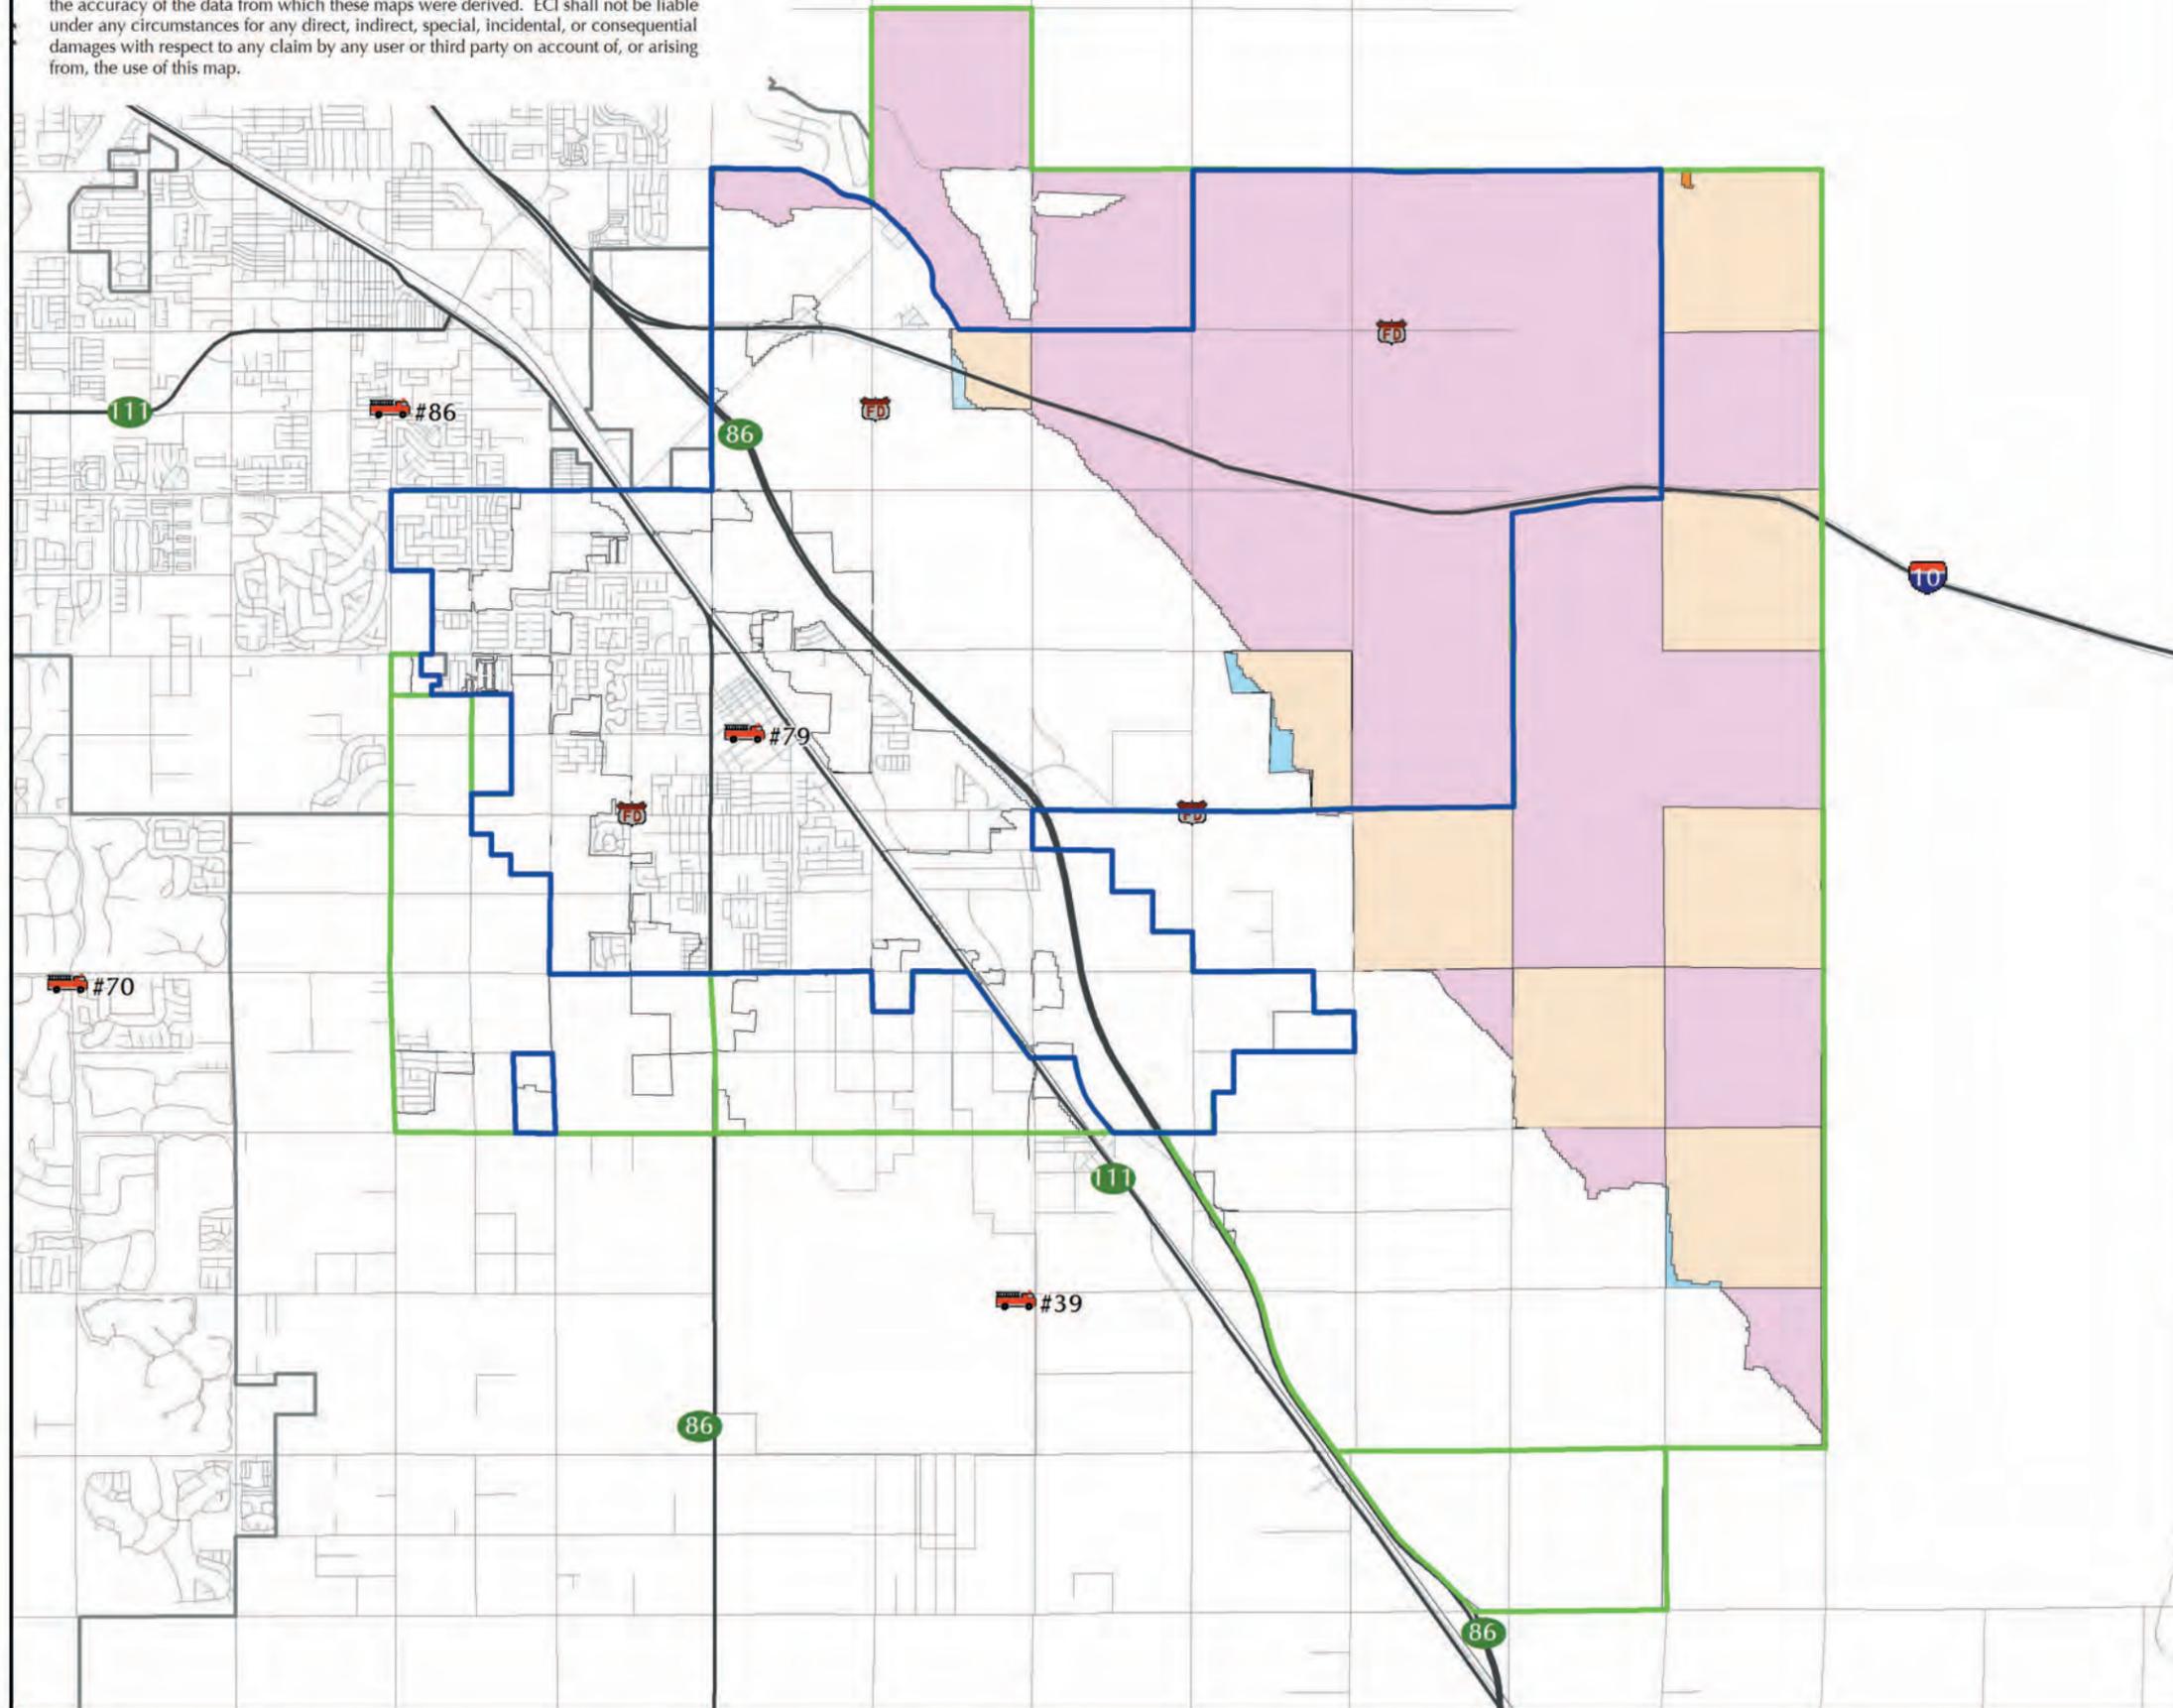
High Fire Hazard Areas

*The CDF (2008) recommended that the hillside areas in the eastern and northeastern portions of Coachella, which are **Local Responsibility Areas**, be classified as having a **moderate fire hazard** (see pink areas on Plate 4-1). There are no very high fire hazard severity zones in the Coachella General Plan area. The developed areas in the valley floor are mapped as Non-Wildland or Urban Unzoned, and are considered to not have a wildland fire hazard.*

Fire-fighting resources in Coachella and the immediate surrounding area include the fire stations listed in Table 4-3 and shown on Plate 4-1. The general telephone number for the Riverside County Fire Department, Battalion 6 Headquarters (Station 79 in Coachella) is **760-398-8895**. **For emergencies, dial 911.**
