High Fire Hazard Areas

Coachella, California

Project Number: 3106/3218
Date: 2014

**TECHNICAL BACKGROUND REPORT TO THE SAFETY ELEMENT
CITY of COACHELLA, CALIFORNIA**

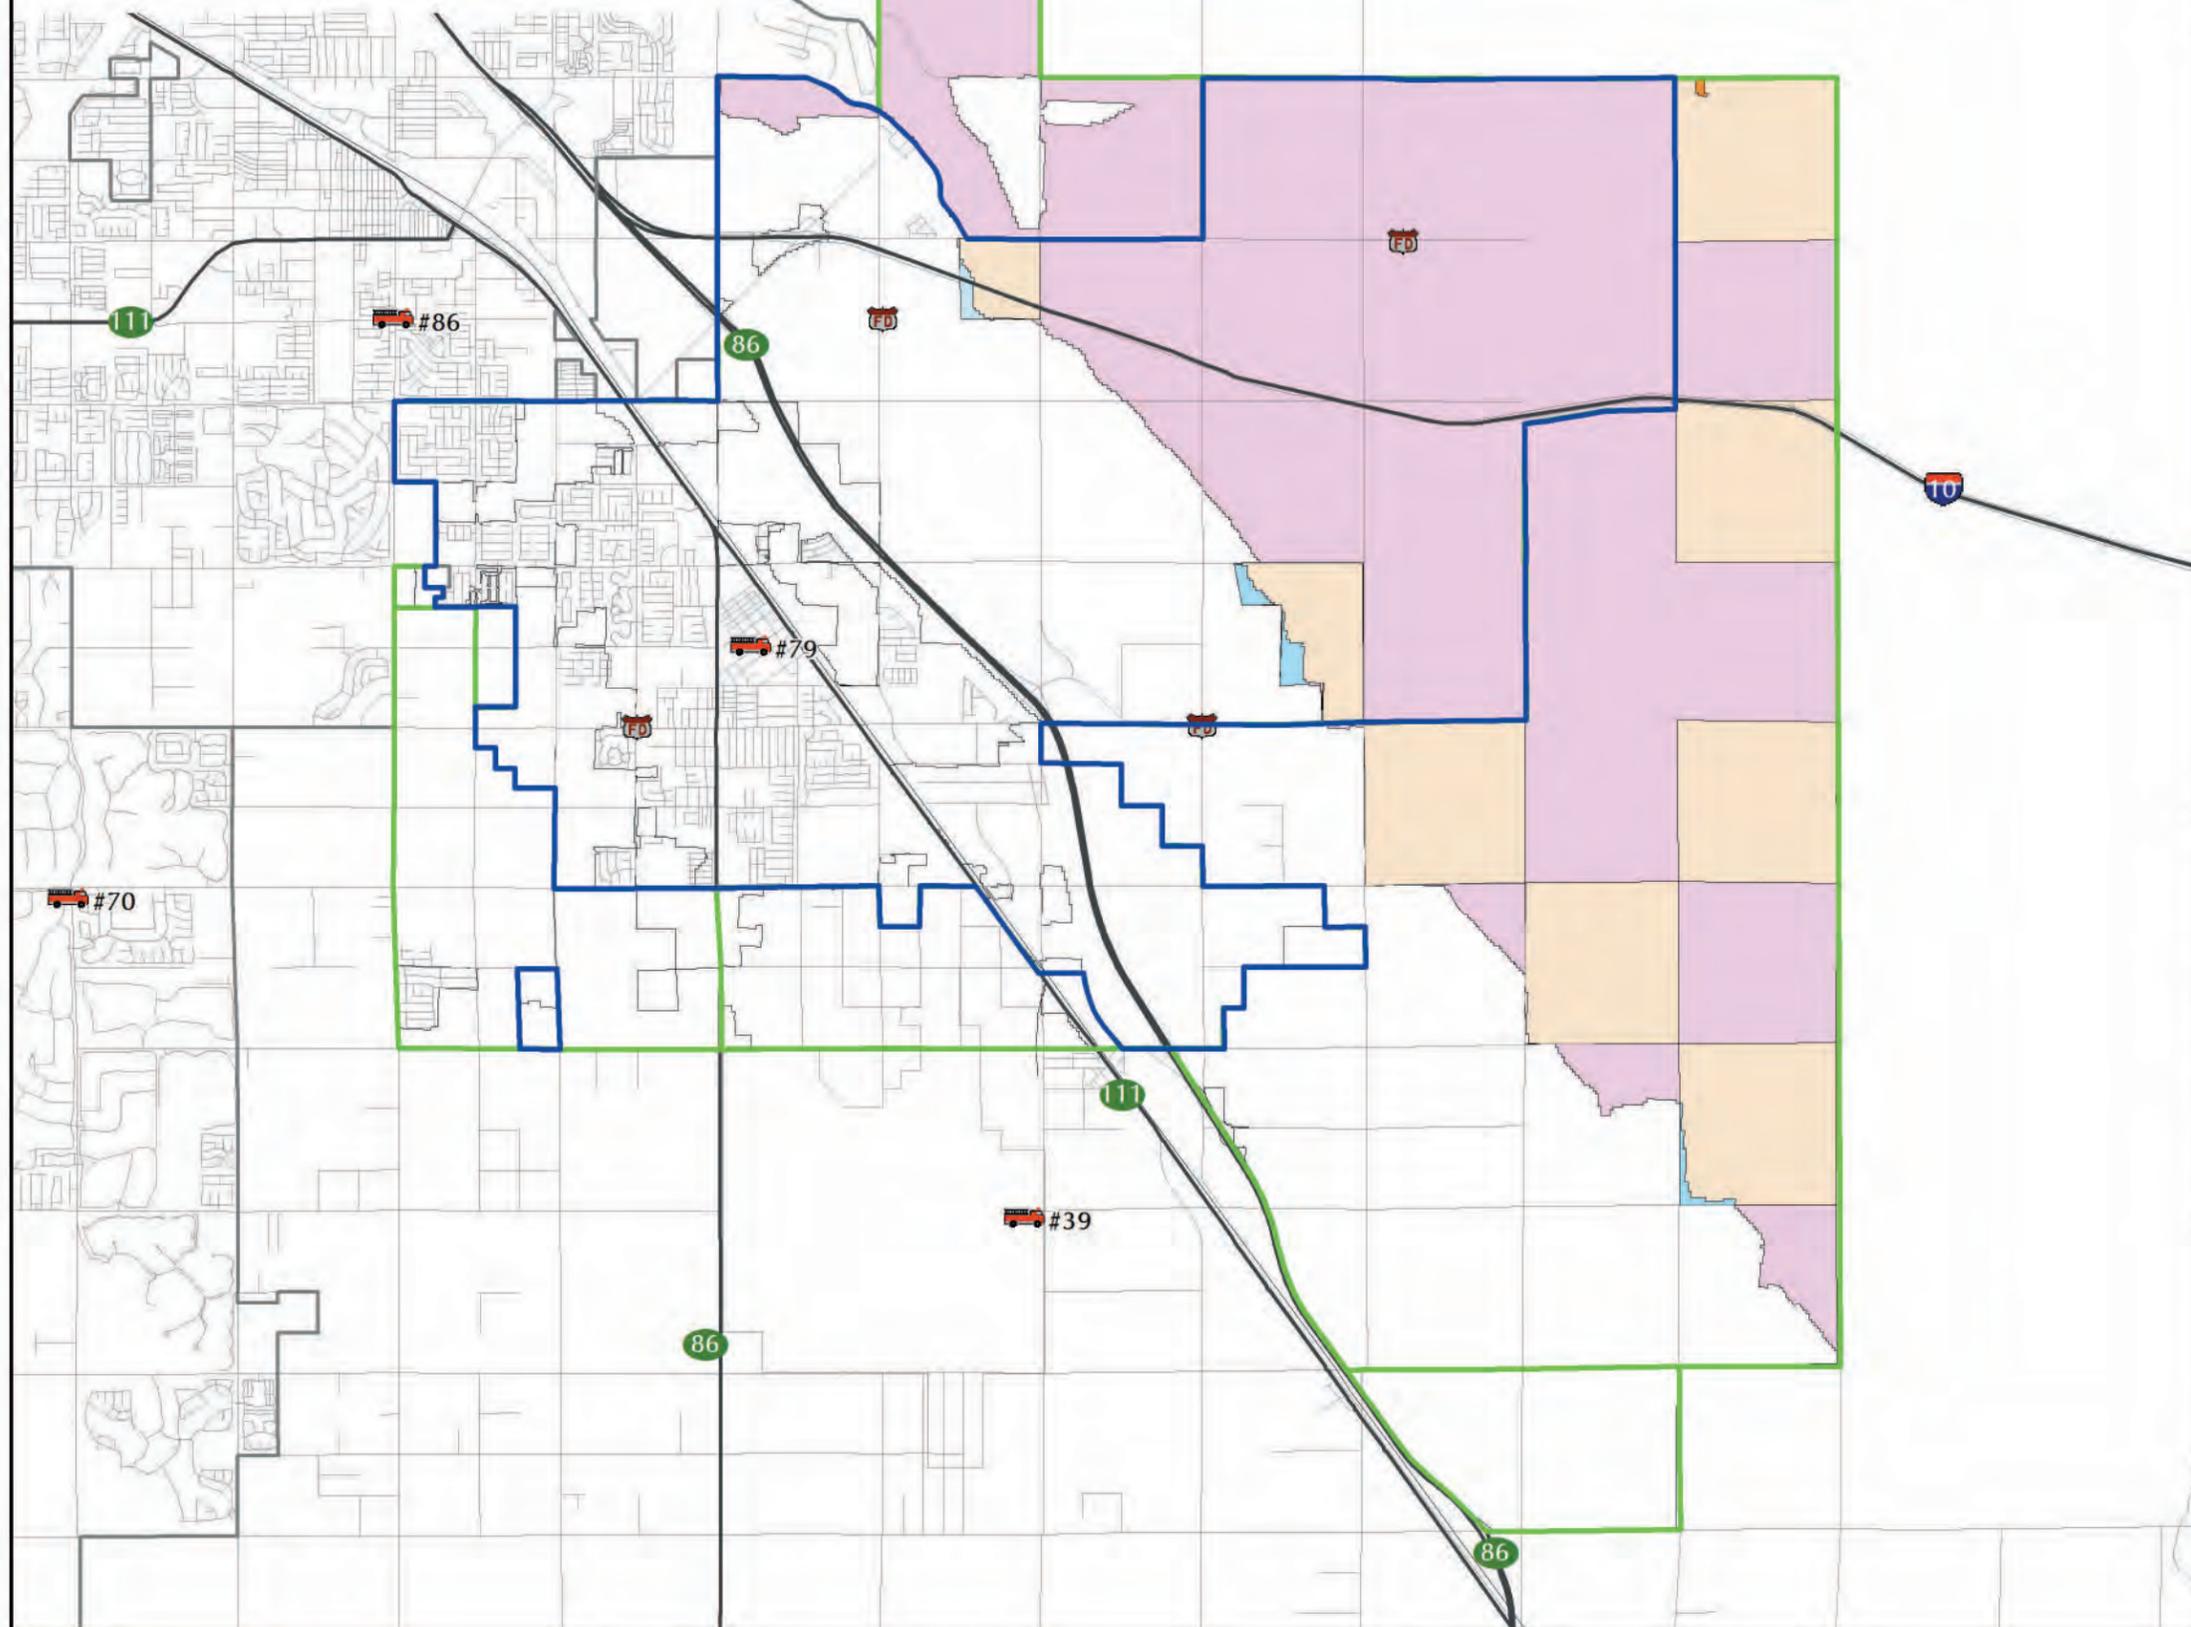
Possible future fire station in the McNaughton area not shown.

*Under the California Plan, most of the Coachella General Plan area east of the Coachella Canal, given the area's vegetation types and slope characteristics, is mapped as having a **moderate fuel rank** and **potential fire behavior**, with isolated pockets of high fuel rank potential fire behavior (<http://frap.cdf.ca.gov/data/frapgismaps/download.asp>). The western and southwestern portions of the General Plan area are mapped as having non-wildland fuel.*

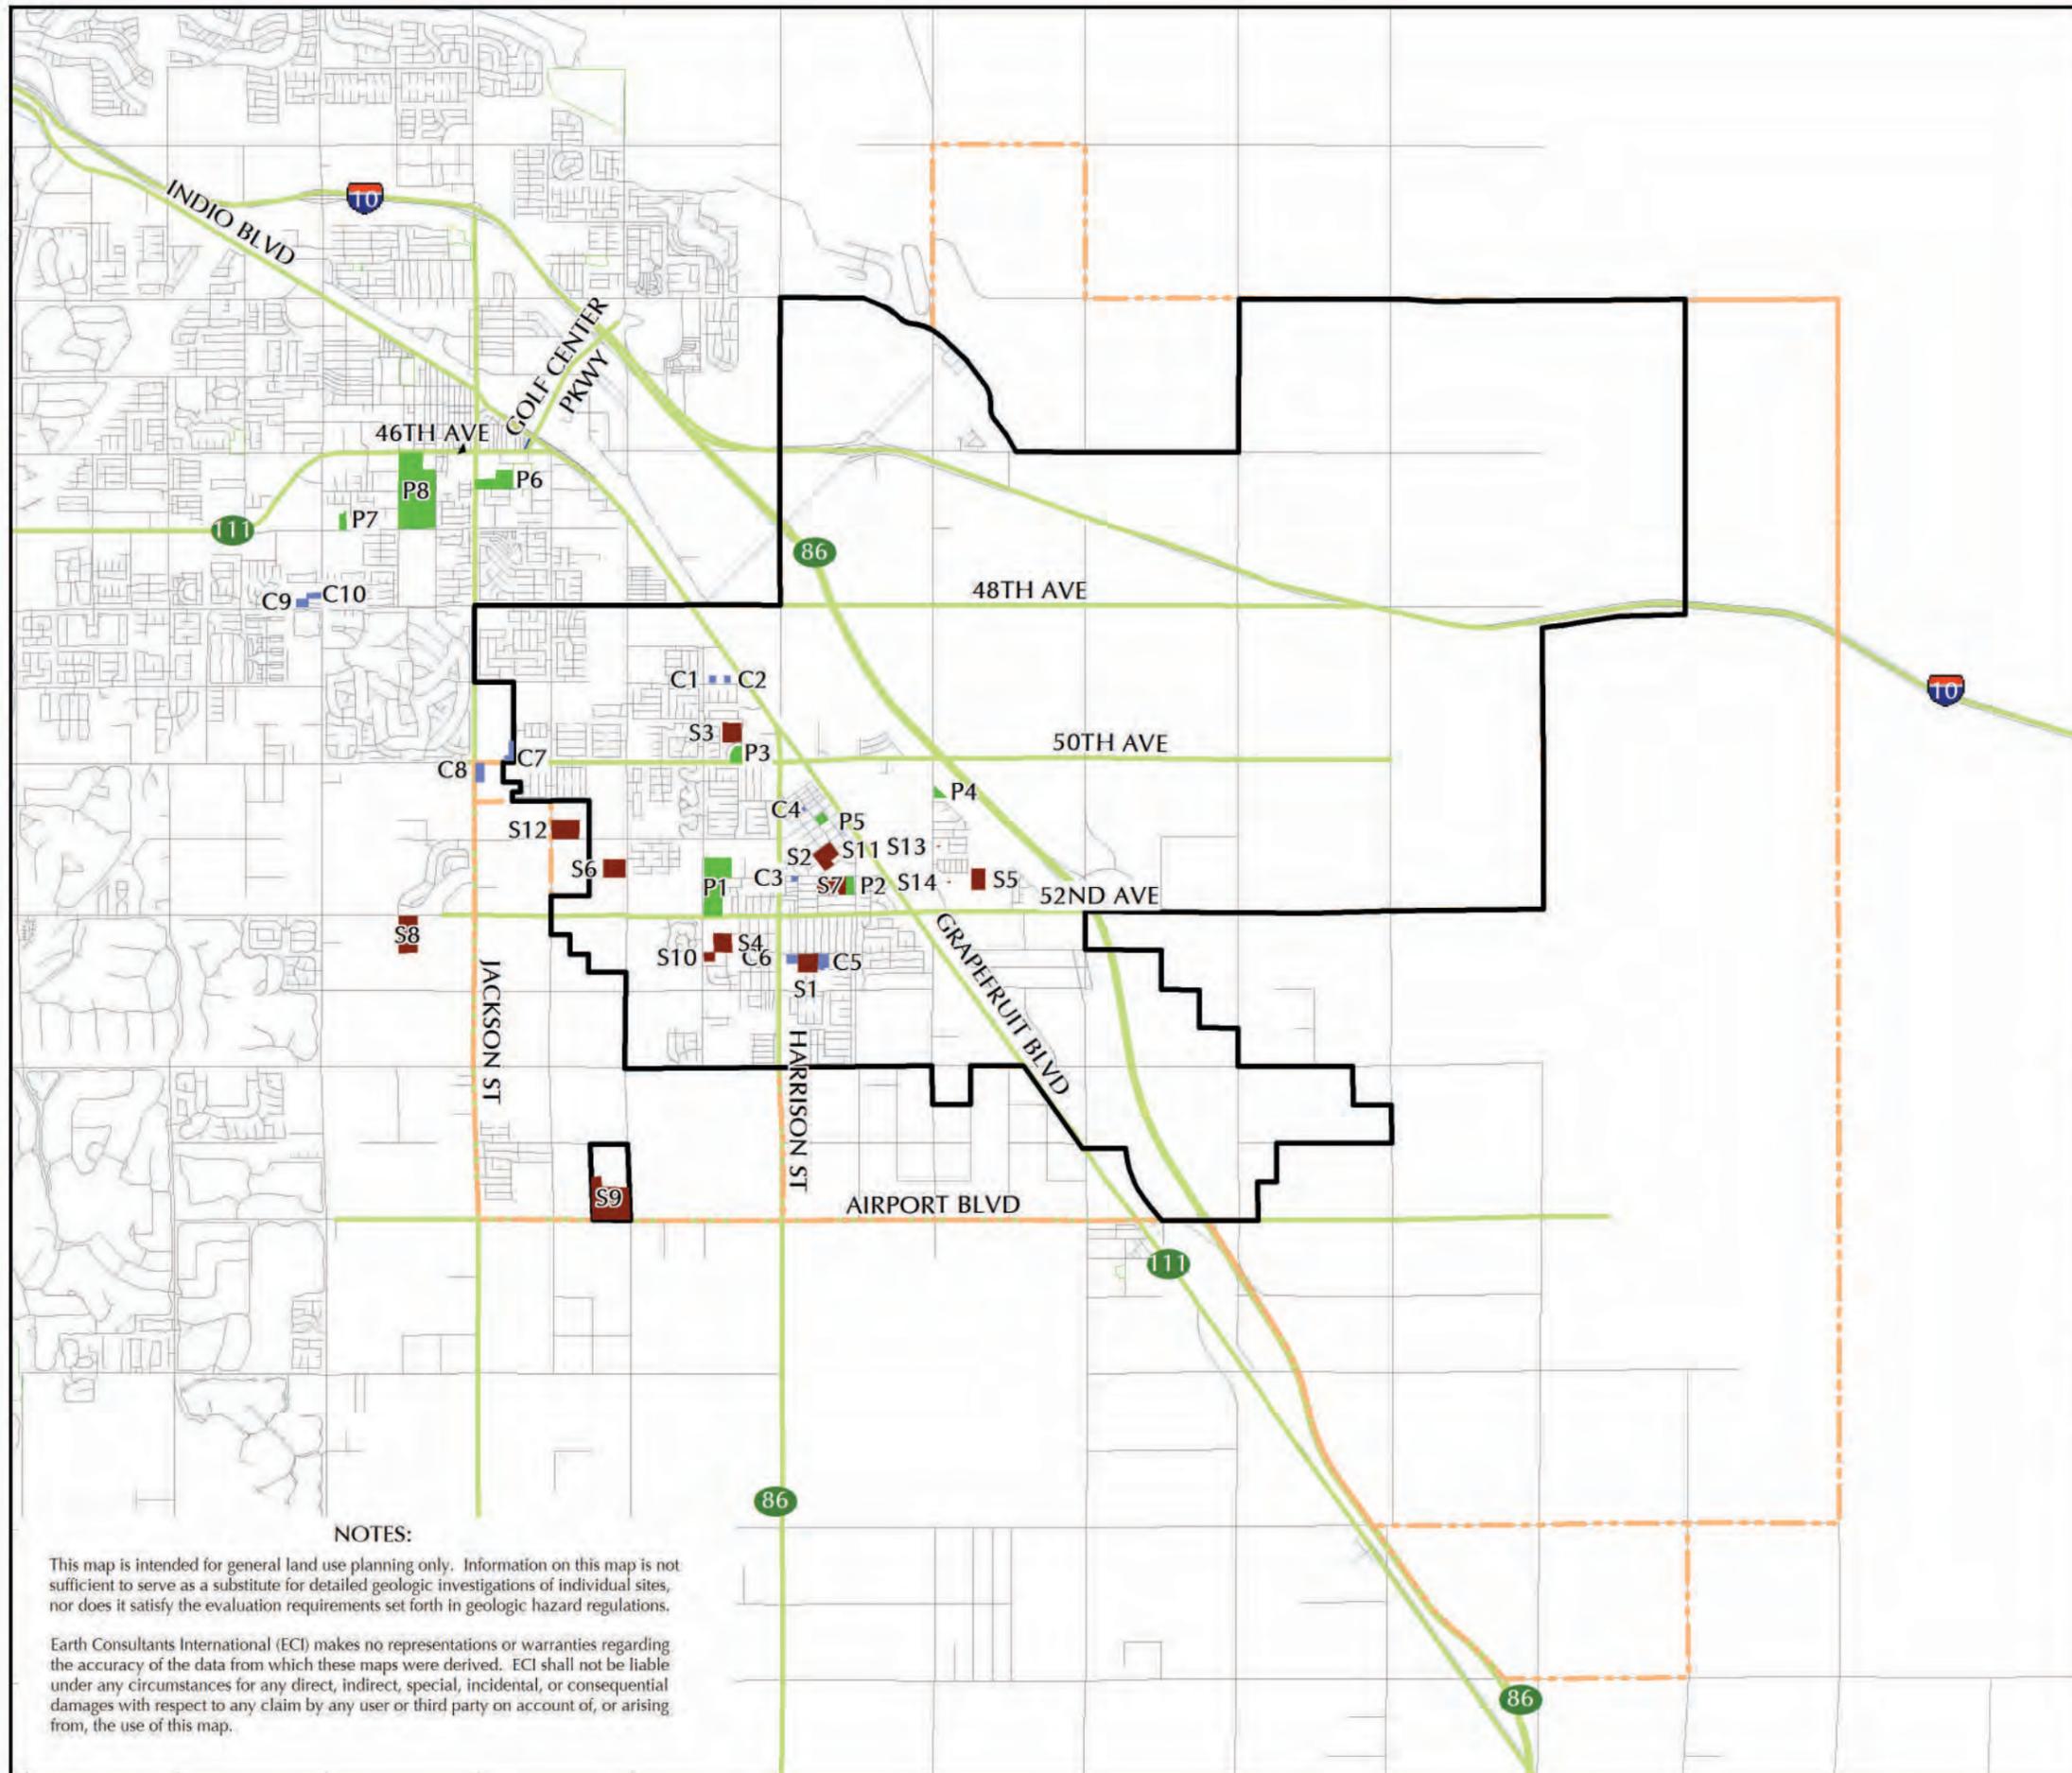
Potential Emergency Shelters and Evacuation Routes

Coachella, California

- S14 School Property
- P8 Park
- C10 Church Property
- Evacuation Routes
- Coachella City Boundary
- Coachella Planning Area Boundary
